St. Mary River Irrigation District

Gabion Wall Infiltration Systems

Aquatic Weed & Algae Control Structures (2010): IRP #2192

Performance Update

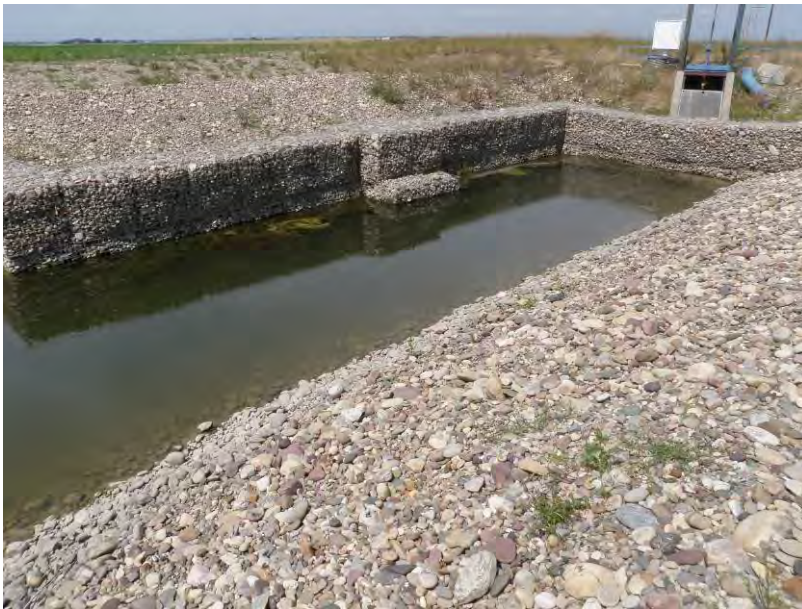
CHIN LATERAL 7 SETTling POND

The Chin Lateral 7 Settling Pond was observed July 22, August 6 and August 11 during the irrigation season. The highest loading is shown in these photographs and was observed on August 11th. Both aquatic weed and filamentous algae mats are present on the upstream side. The Water Coordinator indicated that the total growth of aquatic weeds and algae was similar to

previous years, but lower than normal flows through most of the irrigation season meant that less migrated toward the pipeline inlet.

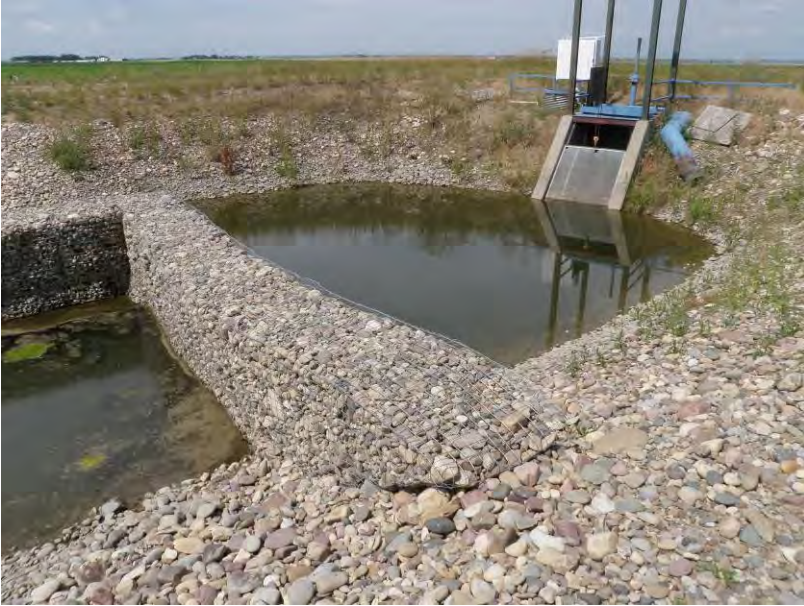
In this second photo the distinct change in presence of aquatic weeds and algae on either side of the wall is observed. The fine screen on the inlet structure was in place during the entire irrigation season with no accumulation. Irrigators reported to the Water Coordinator that the gabion wall “is a blessing to them” and that they are not needing to clean their on-farm pressure filters very often compared to previous years.

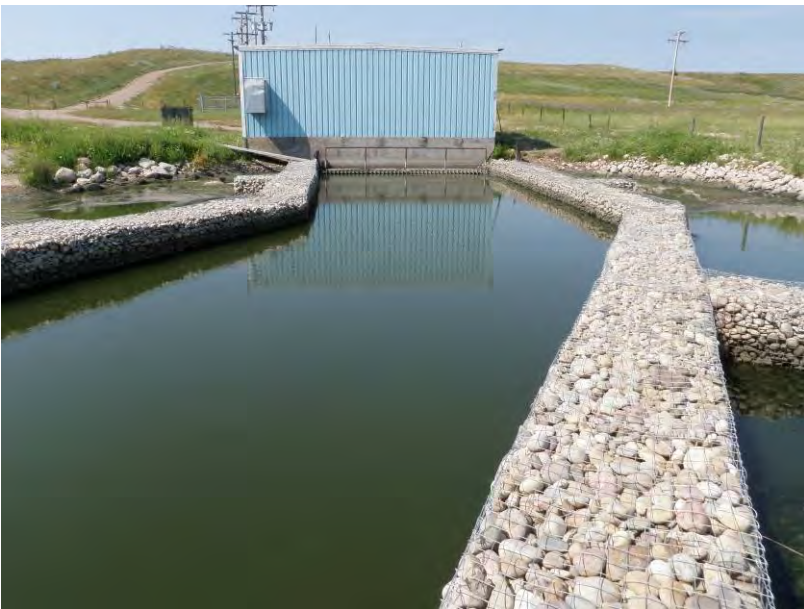
YELLOW LAKE PUMP STRUCTURE INLET

The Yellow Lake Pump Structure Inlet was observed June 29, July 22, August 5 and August 18. Screened sampling and qualitative analysis of the upstream and downstream water were completed once significant aquatic weed and algae loading entered the inlet bay. This photo shows the general configuration of the gabion wall infiltration system relative to the inlet.

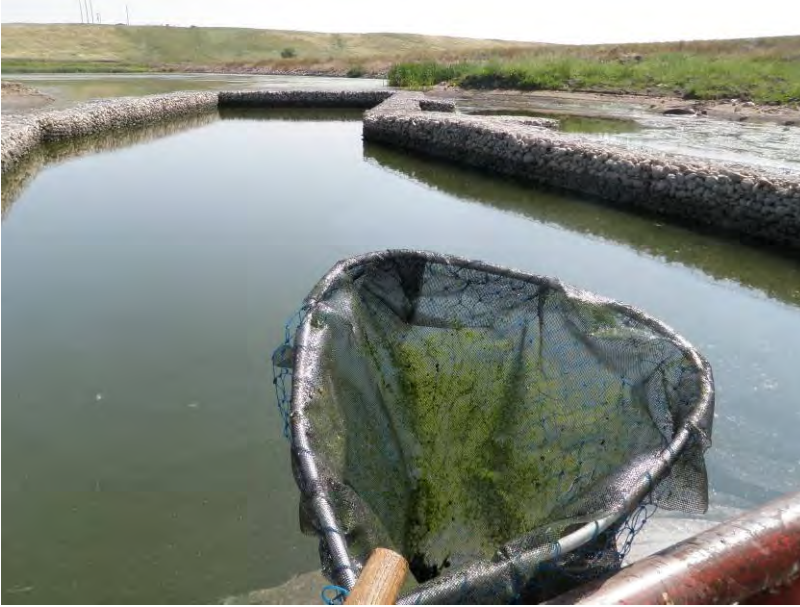
This second photo shows the results of a double deep sweep (approx. 2 m) along the inside of the wall approximately 10 m from the inlet on the east side (photo is facing south). The organics collected in the screened material include short filaments of algae and freshwater shrimp.

- Cover the top of the wall with wire mesh where operation, maintenance or inspections require.
- Where free-floating or short filaments of algae (Yellow Lake Pump Structure Inlet) are passing through the wall, supplemental filtering could be obtained by installing temporary organic filter mats on the upstream side of the wall. Products such as erosion control blankets may be tested at this site to reduce the potential downstream "seeding" of the North Grassy and North Burdett canal systems.

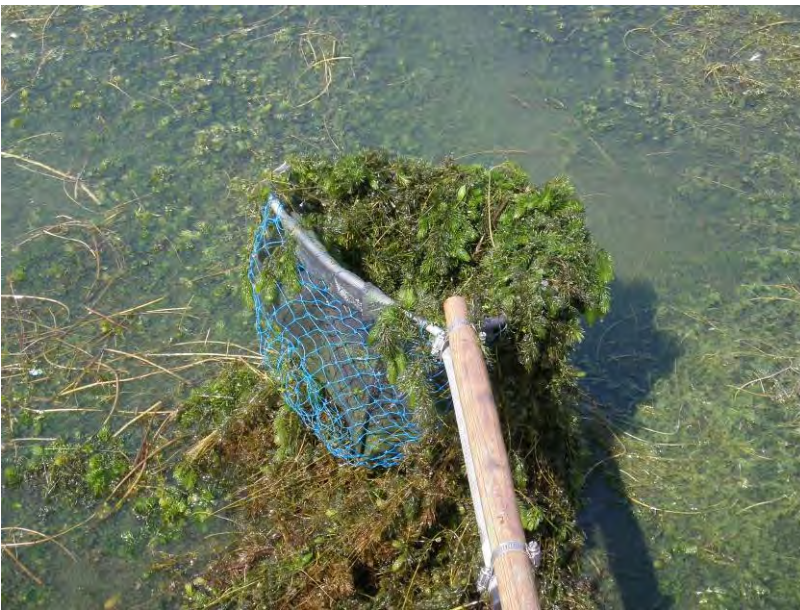
This third photo shows a sample of weeds (primarily coontail) retrieved in a single pass shallow sweep opposite the sample take on the inside of the wall. Probing indicated that the weed mat was quite deep, possibly accumulating to the bed of the bay. Note the higher cloudiness of the upstream water, indicating that at least a portion of the algal filaments are being filtered by the upstream aquatic weed mass.

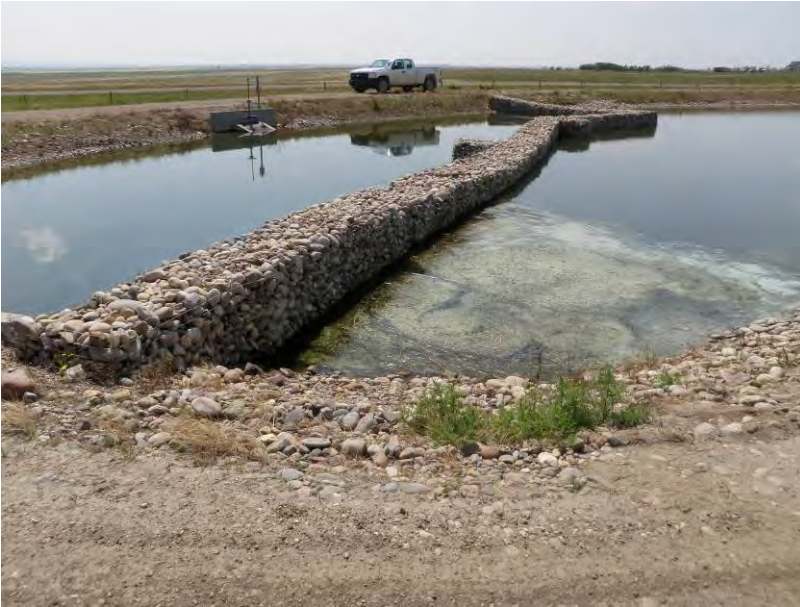
WEST MEDICINE HAT LATERAL 18&20 SETTLING POND

The West Medicine Hat Lateral 18&20 Settling Pond was observed July 22, August 6 and August 18. Although the primary historic problem in this dead-end canal is filamentous algae mats, this photo shows that long-stemmed submerged weeds are an additional problem that was excluded by the gabion wall infiltration system.

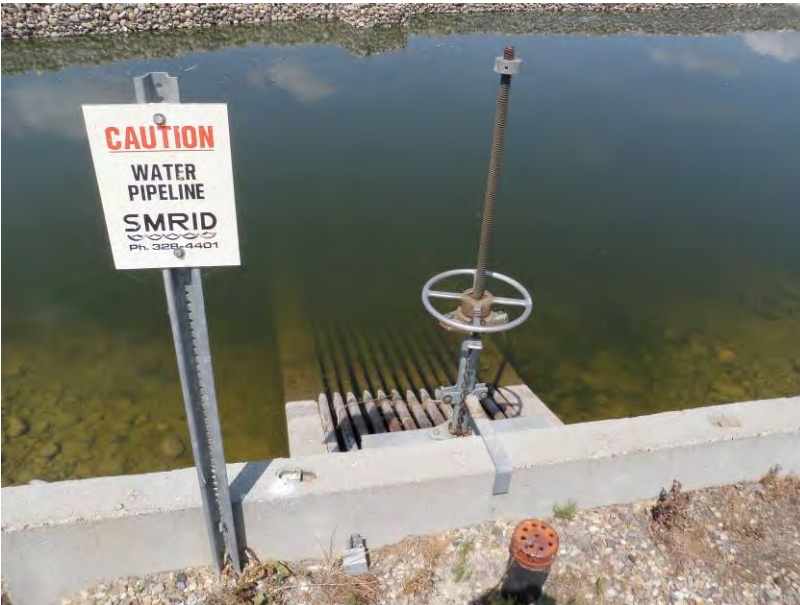
This second photo shows that the trash rack on the pipeline inlet structure remained clear of aquatic weeds and algae.

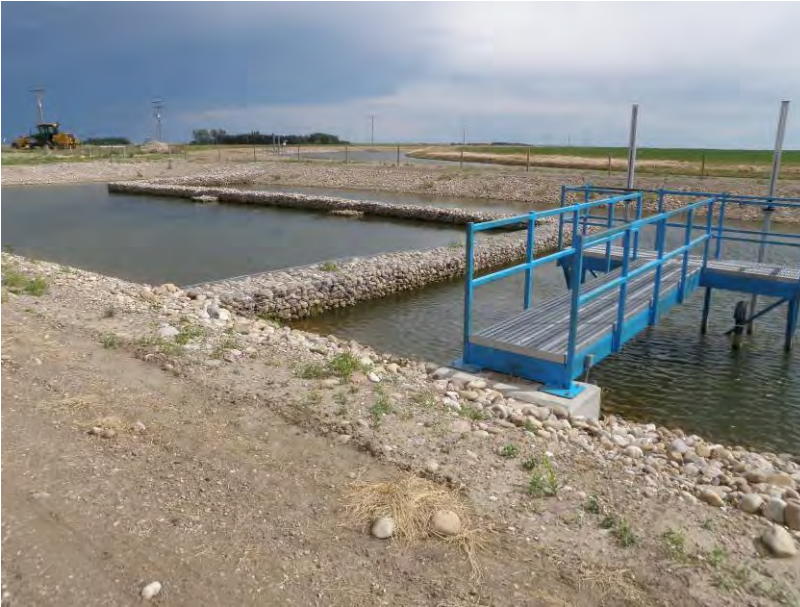
YELLOW LAKE LATERAL 4 SETTLING POND

The Yellow Lake Lateral 4 Settling Pond was observed June 29, July 22, August 5 and August 18.

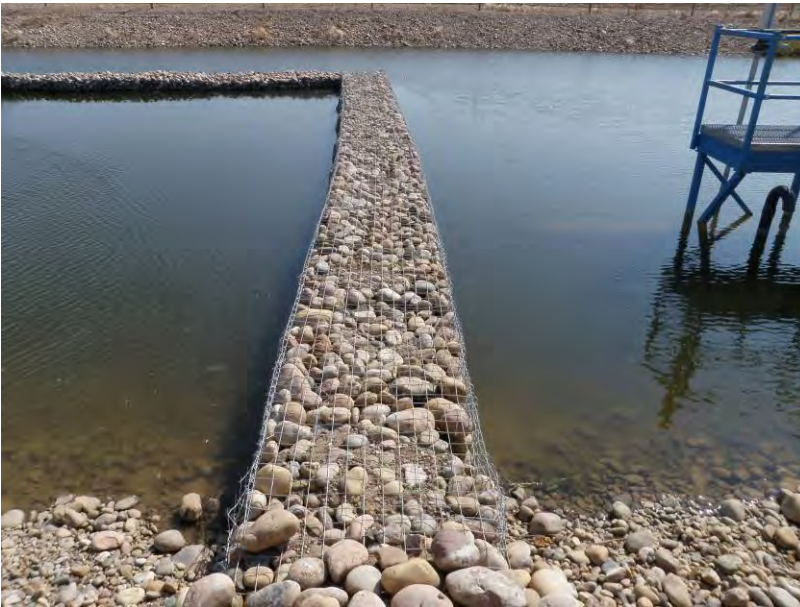
Very low irrigation demand and negligible aquatic weed and algae loading were typical of this system for the 2010 irrigation season.

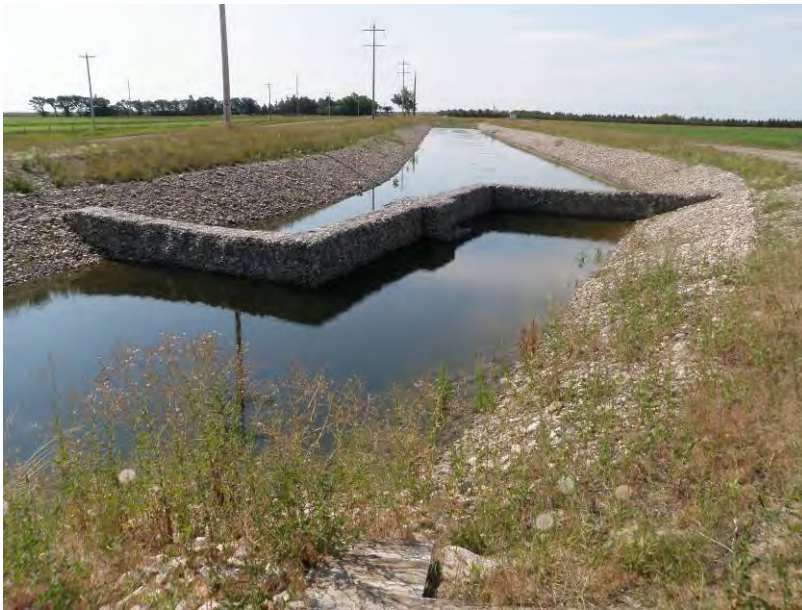
CHIN LATERAL 7 SETTLING POND

There were two days of during the 2010 irrigation season during which the Chin Lateral 7 system was operating near design flows. The Water Coordinator indicated that during this time aquatic weeds and algae that were growing in the canal was being transported to the gabion wall. There was no measurable difference in the water level on either side of the wall, indicating negligible hydraulic restriction with low weed loading.

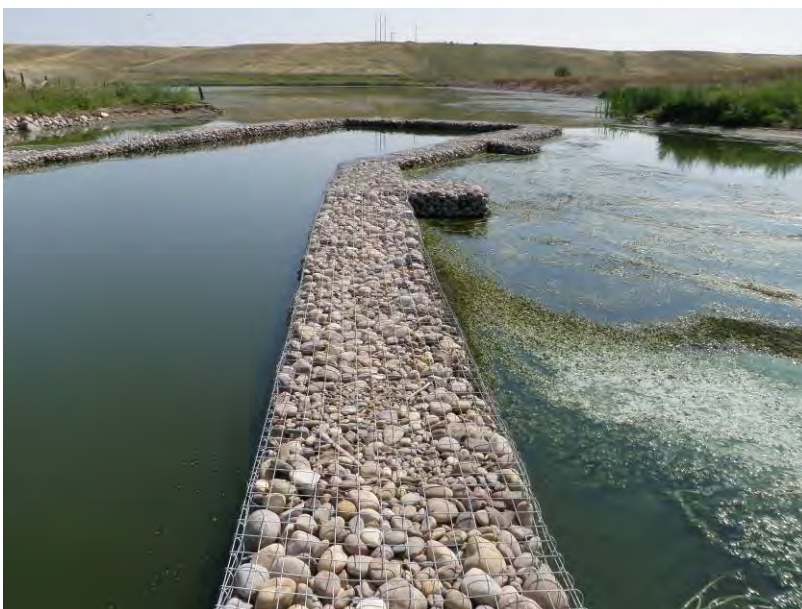
YELLOW LAKE PUMP STRUCTURE INLET

Due to high runoff, both pumps were operated through the entire 2010 irrigation season. At maximum weed loading, there was no measurable difference in water level on either side of the wall. A careful inspection along the wall revealed that inflow was relatively uniform, indicating that flow was maintained through the weed mat. A high factor of safety was used in setting the design

velocity at this site due to low accessibility for maintenance. The low velocity through the wall ensured that entrainment against the structure was avoided. Maintaining velocities below the entrainment velocity avoids compression of the weed mat, permitting infiltration of water throughout. The self-compensating nature of the infiltration system aids in maintaining uniform flow such that a small change in resistance in one area results in a small increase in flow in another such that the magnitude of the restriction is limited. This will continue to be valid so long as entrainment velocities are not reached such that zones of complete blockage are not formed. Ongoing evaluation of the hydraulic performance of these systems will permit refinement of design principles to avoid failure and to improve economics based on site specific conditions as well as expand applicability to a greater number of existing sites.

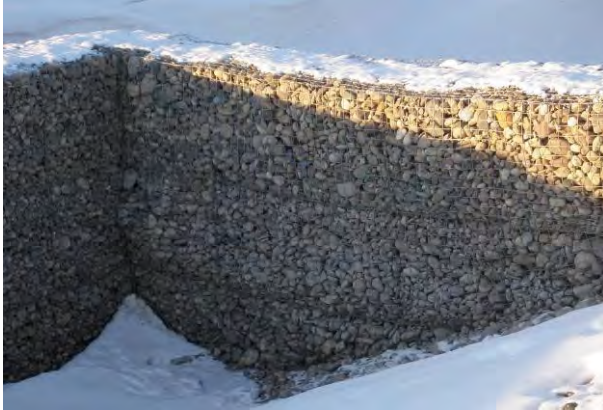
There was only one area of the Chin Lateral 7 structure that had excessive bulging due to a longer than 1m long cell used on a custom fit to the bank.

A small swale is noticeable, but the forces seem to have been distributed throughout with no breakage of strands or welds. The inclusion of freeboard height ensures this structure will not be overtopped during high demand.

- Minor hand sorting and light (foot) tamping of gabion fill improves the tightness of the fit in each cell and will reduce settlement potential.
- When custom cutting for slopes, ensure cell length does not exceed 1 m and sufficient stiffeners and internal panels are in place to retain the shape.
