the WATER HAULER'S BULLETIN

VOLUME 24
SUMMER 86
ISSN 0827-2212

SURROGATE LINER

Aqua Liner Canada Thinks There is a Better Way

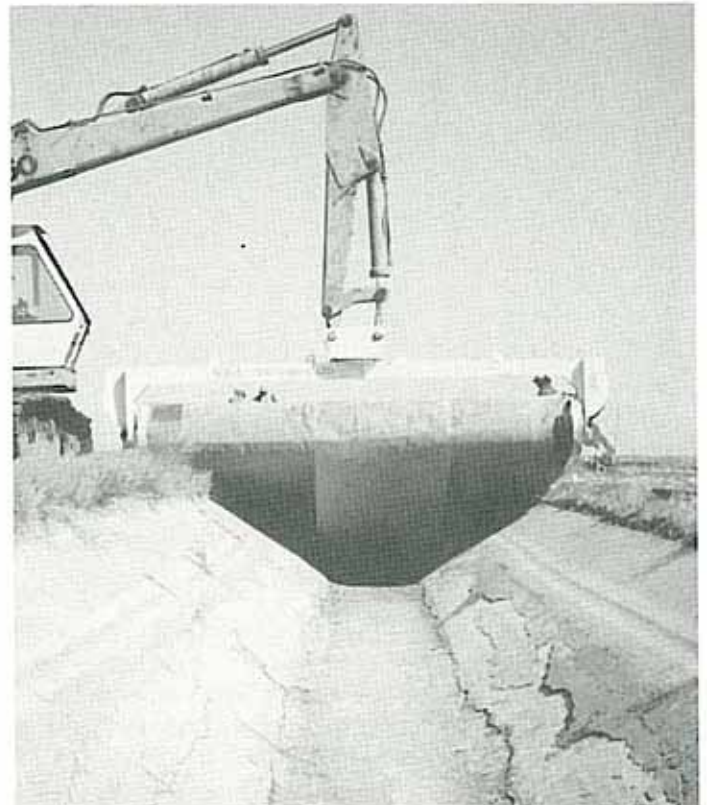
The problem facing the Bow River Irrigation District is how to repair their worst sections of cracked, unreinforced concrete slip-form lined canals. First thoughts were to remove the old liner completely, and replace it with a new reinforced concrete liner, however, this is very expensive, and would probably not be eligible again for cost sharing under the Irrigation Capital Works program. Then came the idea of placing a flexible liner inside the existing channel.

Aqua Liner being rolled out over the badly cracked and broken concrete lined channel.

The bed of the existing concrete channel was cleared of any debris such as silt and pieces of broken concrete. Any large cracks or displaced concrete was smoothed with concrete grout to remove the sharp rough edges that might penetrate the Aqua material.

The large heavy rolls of liner were lifted and rolled in place by means of a hydraulic hoe. Once in place, the liner was fastened to the top of the existing concrete by means of galvanized metal strips and Hilti fasteners every 150 mm. The liner was anchored transversely at the start of every roll by the same metal strips and Hilti fasteners. The end flap from the previous roll was overlapped and heat sealed to the new roll.

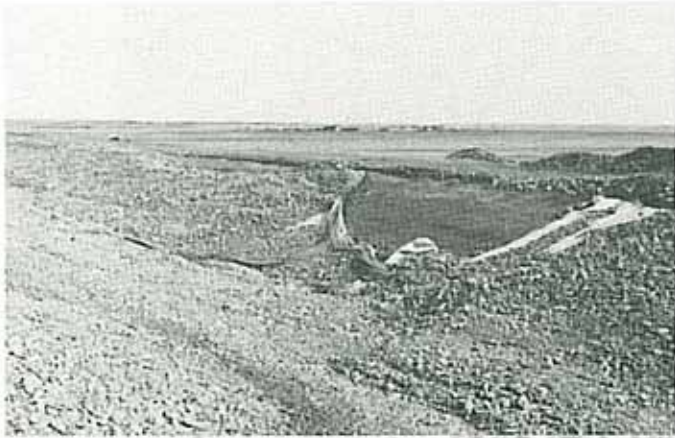
Sloughing of the armour was broken into three categories. First was a total complete sloughing of the bank, with the slide occurring from top to bottom. Second was a partial slough, where only part of the bank had moved (usually the toe). The third category was drainage flow over the bank, causing the armour material to slide or erode down the bank.

Section of canal where armour was directly placed on liner. Note: Sloughing — Investigations Continue.

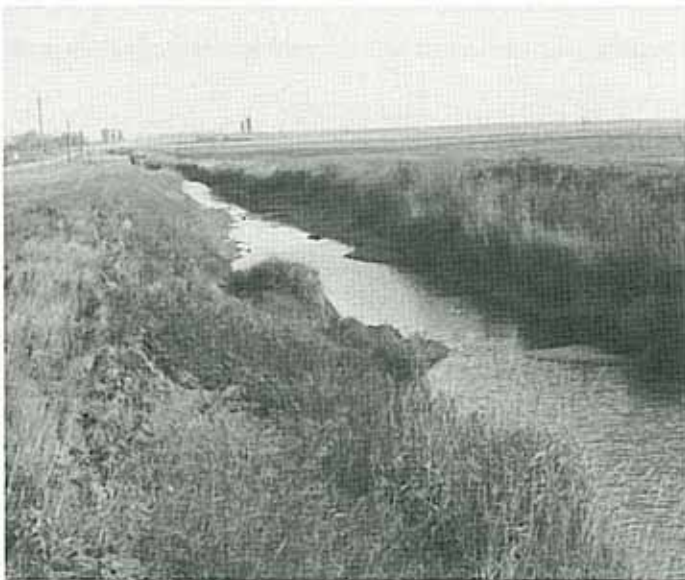
The Lethbridge Northern Irrigation District became increasingly concerned over the progressively worsening bank erosion taking place in their Picture Butte Lateral. Flow velocities in the channel were relatively low, somewhere in the range of 0.76 m/s. Investigations eliminated wave action, but soon centered around the high water fluctuations occurring in the canal during the irrigation season. It was found that these high fluctuations of water levels or "sudden draw-downs" as they are called, created a pumping action of the unprotected material fines in the banks, causing material to slough.

Typical Section of Picture Butte Lateral prior to rehabilitation.

First thoughts were to, just place gravel armour on the unprotected banks. But District Engineers felt that because of the high drawdowns, there would be little gained by directly placing gravel armour on the slopes as the material fines would still be pumped. It was at this point that the District decided to try a geotextile on the slopes and then place gravel armour on top of the 100% polyester material. The geotextile they chose was Nilex U19 having a thickness of 1.5 mm. The District chose to use a geotextile because this material is strong, provides soil reinforcement, allows water to filter through it and yet holds material fines so they do not separate.

During rehabilitation, the canal slopes were trimmed back to a 2.5:1 slope. The geotextile was then laid from the toe of the slope up to the top of the bank and keyed into the bank. The material was not placed in the ca-

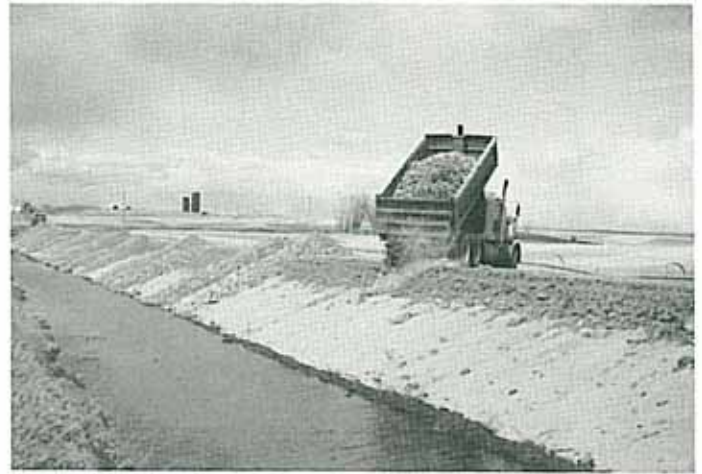
Gravel Armour was dumped directly on U19 Geotextile. A Geotextile will not control seepage.

nal bed. Gravel armour was then placed directly on top of the geotextile to a depth of 175 mm.

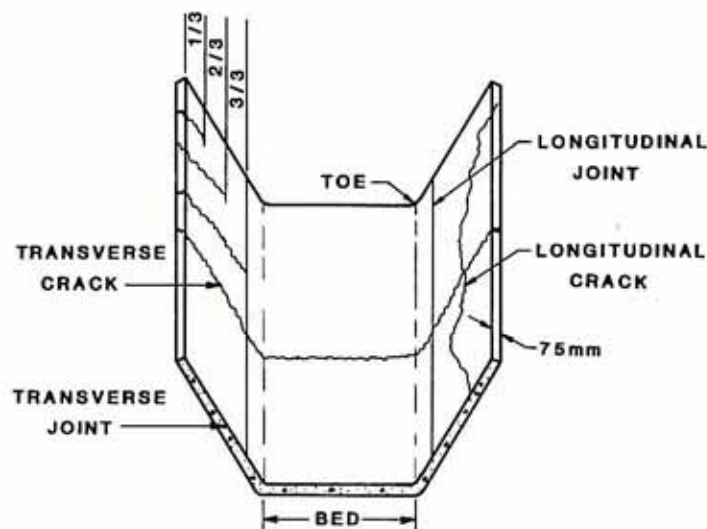
**X - SECTION OF
CONCRETE LINED DITCH**

CRACKING	UNCRAKED	UP TO 5 mm	5 mm TO 40 mm	OVER 40 mm
Overall	96.20%	3.54%	0.25%	0.01%
Transverse	98.20%	1.75%	0.04%	0.01%
Longitudinal	98.00%	1.79%	0.21%	—

- (3) There was an increase of 98.6% in transverse cracks and 102.9% increase in longitudinal cracks from the 1985 inventory.
- (4) When looking downstream, 36.7% of the cracks are on the left slope; 32.8% on the right slope, 28% in the bed and 2.5% across the ditch transversely.

One theory that can be advanced as to why the sudden 100% increase in cracks from 1985 to 1986 may be found in this past fall's extreme weather. Heavy rains fell through much of September and into October. The saturated pads began to freeze by mid October with the unseasonably below normal temperatures causing more severe frost action ■
