Using Fiberglass (GFRP) Rebar in Infrastructure and Building Applications

Presented by
Malcolm McNeill, FRP Distributors Inc
Manufacturers Representative for BP Composites Ltd.

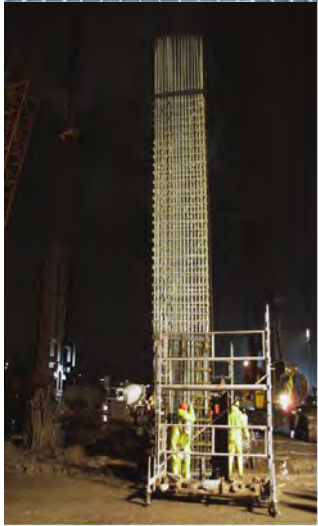
GFRP rebar cage being prepared for installation of the soft-eye.

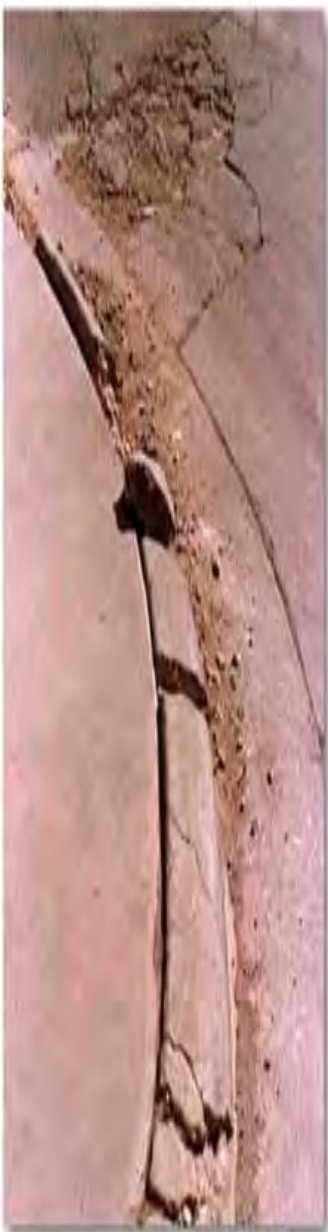
This un conventionally-shaped curb and the adjacent street have sustained substantial damage and deterioration.

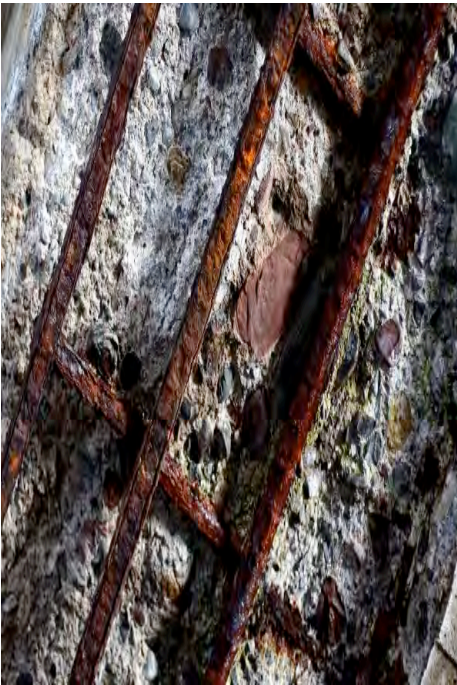
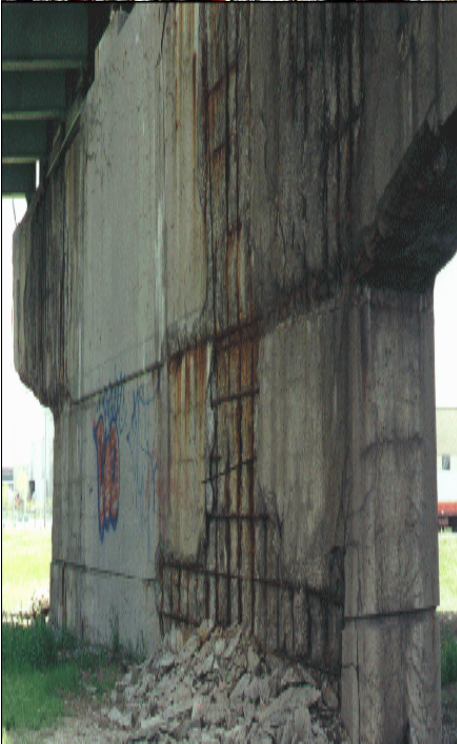
Images of 16 year old epoxy coated steel reinforcement from Humber River Ontario Bridge, MTO Ontario 1998

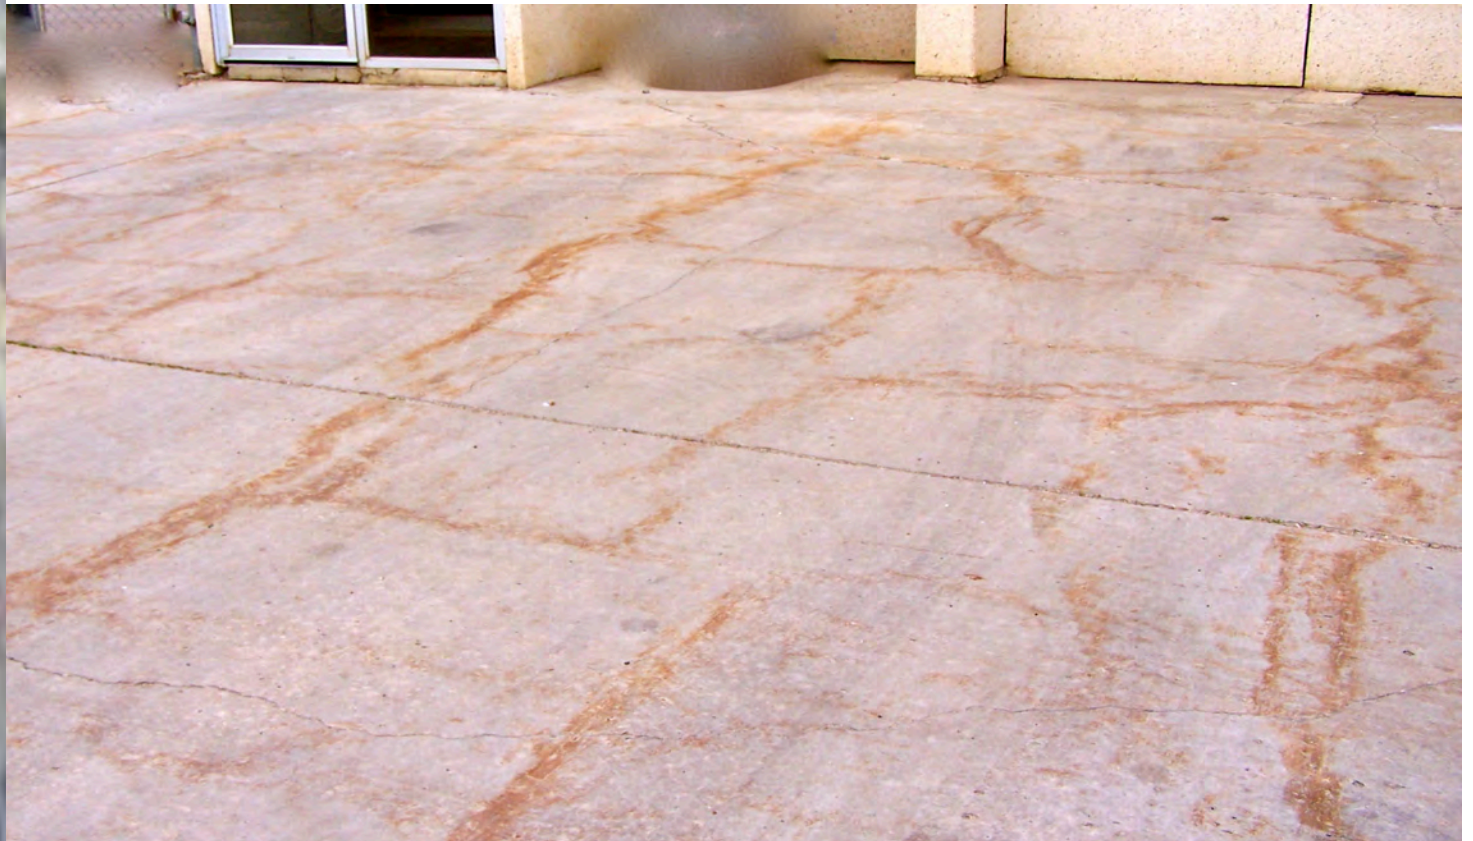
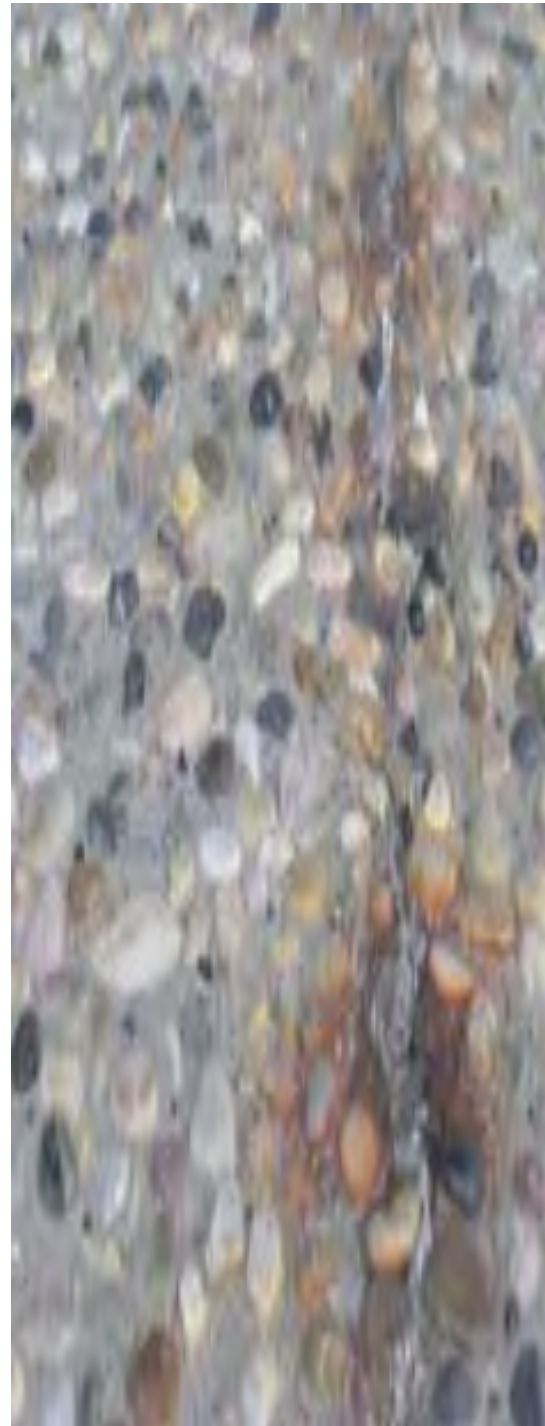
On left: 19-year-old Ontario Epoxy Coated reinforced bridge barrier experiences delaminating cracks.

Below: 23-year-old Galvanized reinforced bridge deck suffering from corrosion induced cracking.

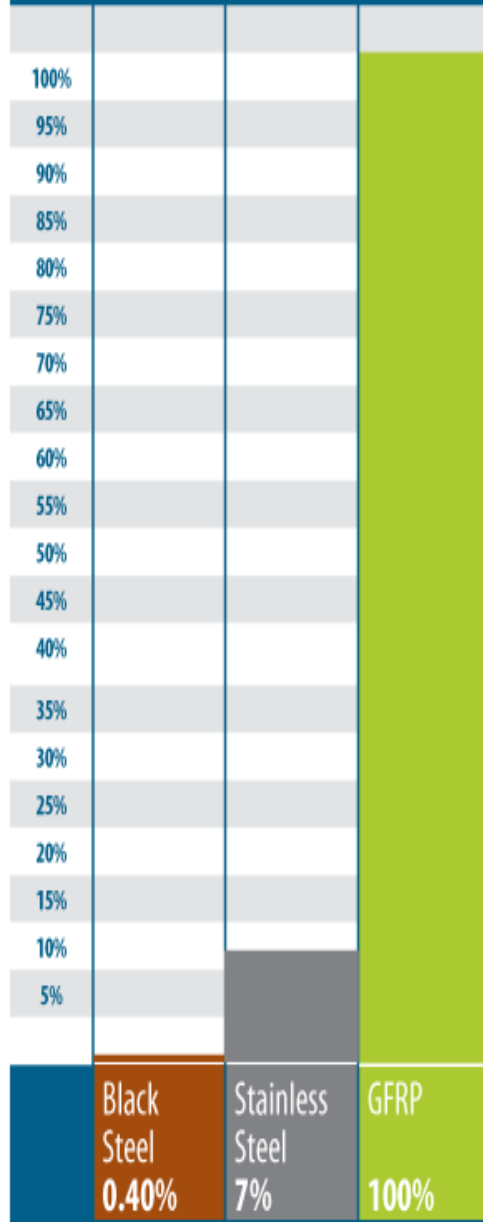
CHLORIDE RESISTANCE CHART GFRP vs STEEL

Maximum Chloride Tolerance Levels

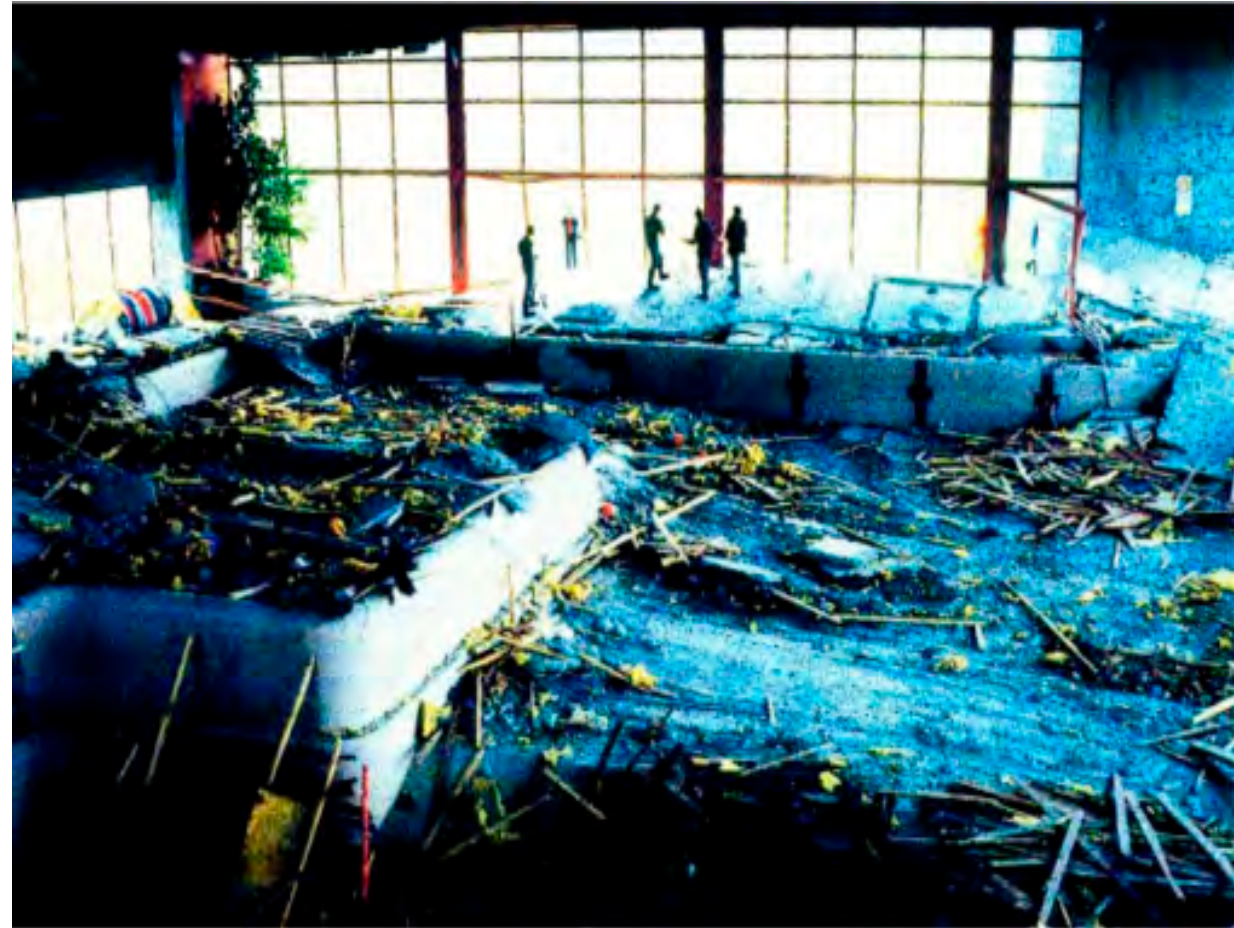
13 year old swimming pool roof in Switzerland collapsed after failure of stainless steel rods due to chloride induced corrosion.

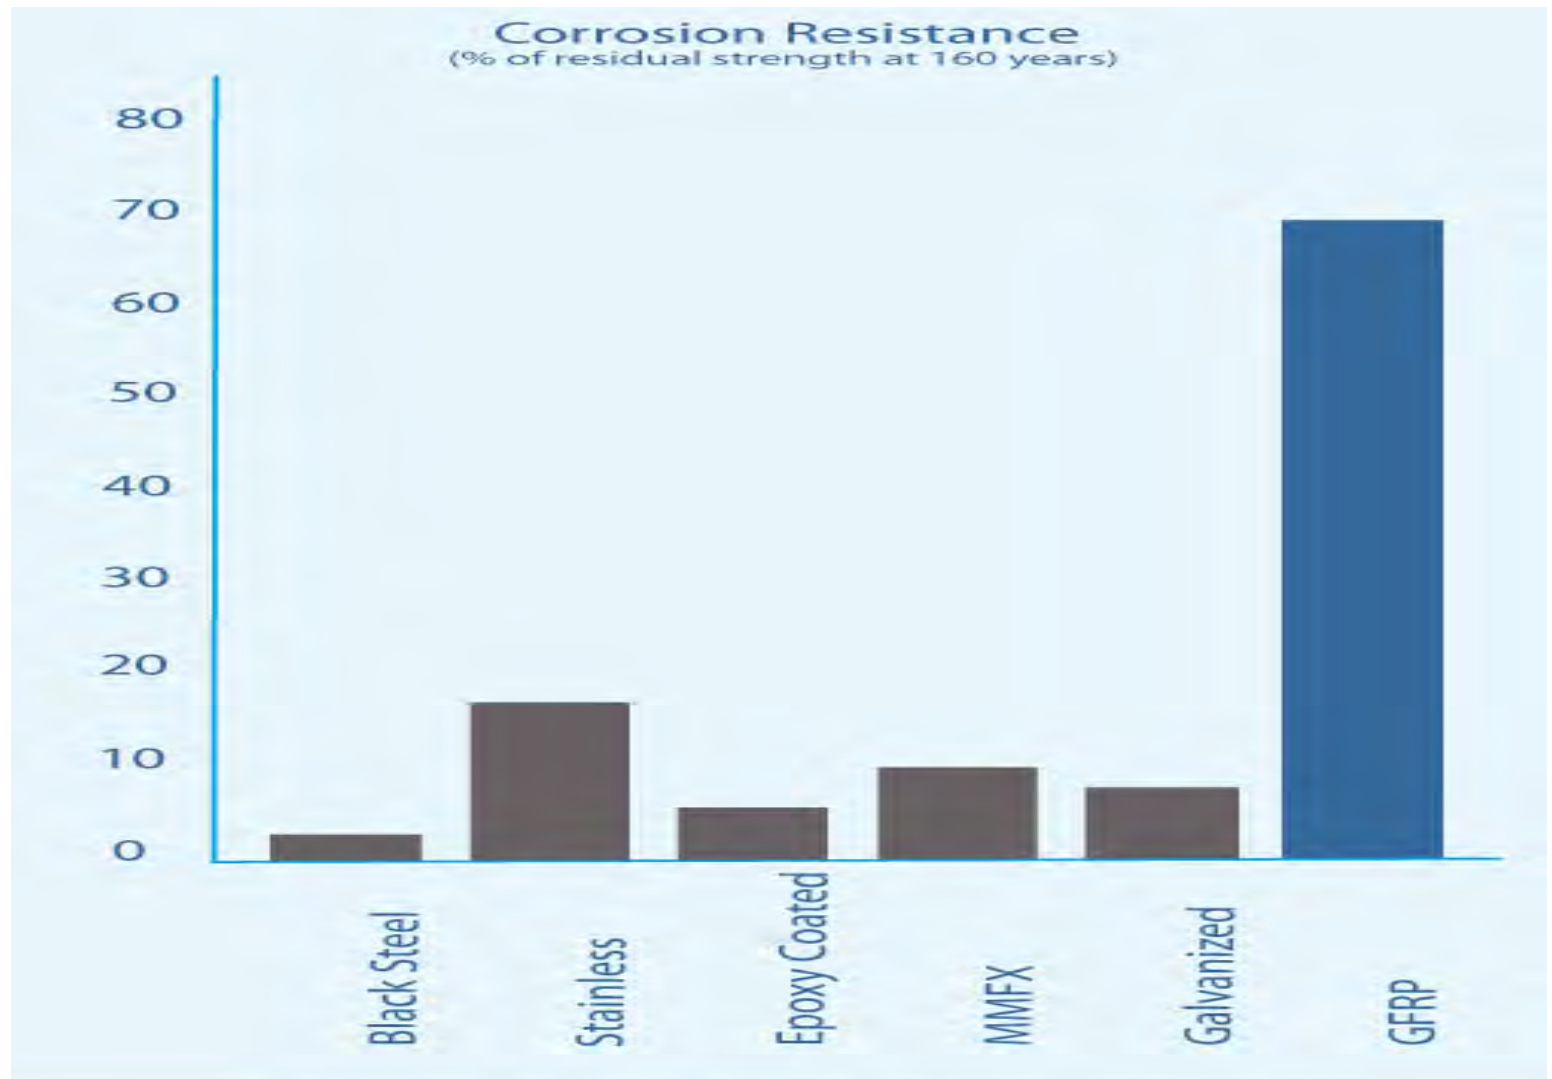
- Residual strength at 160 years

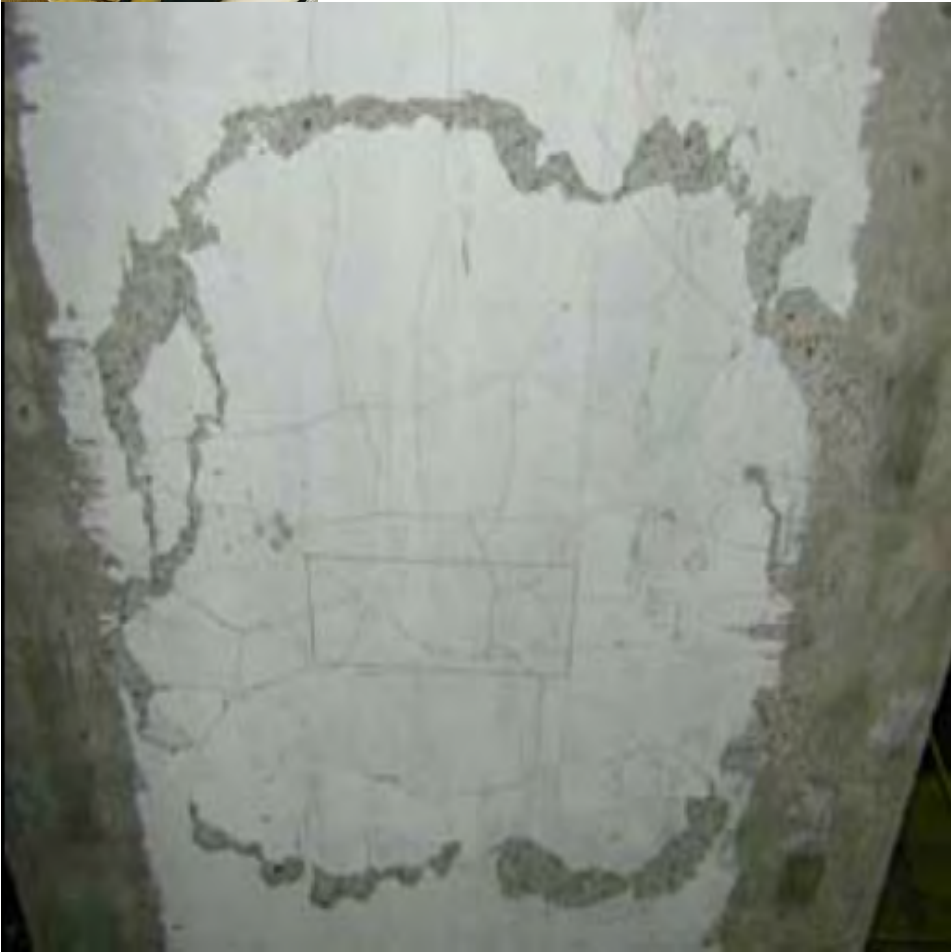
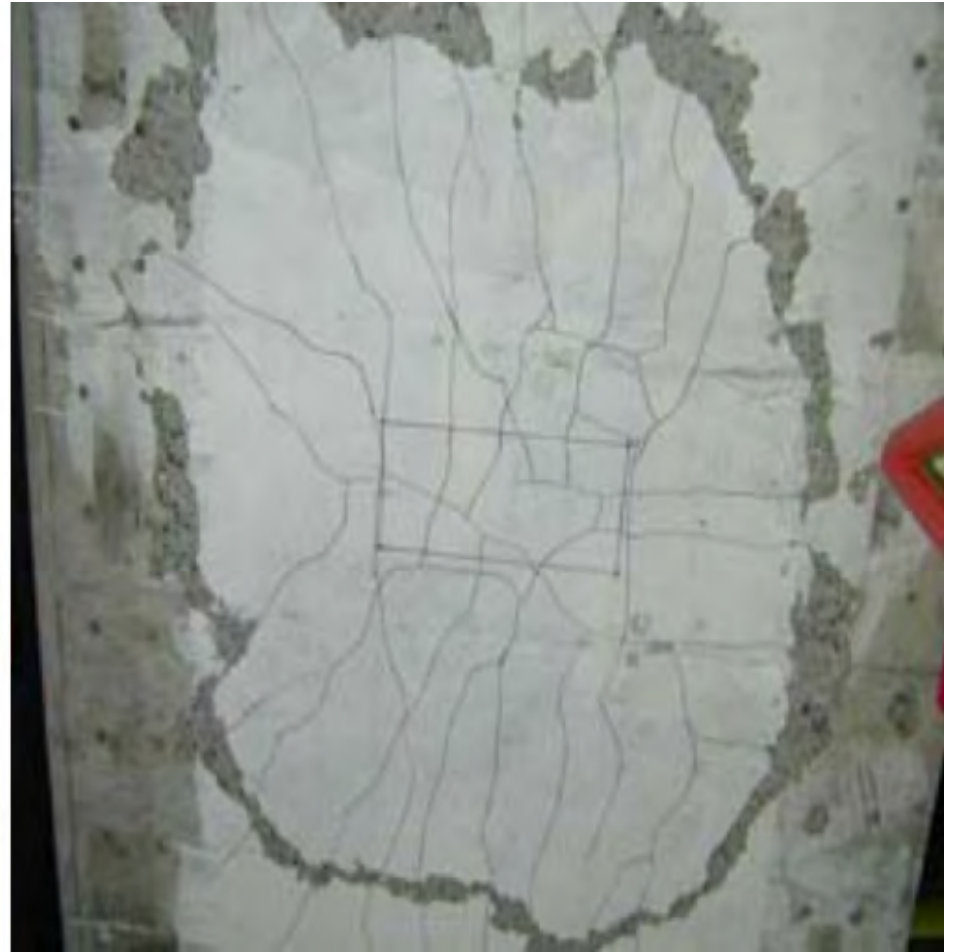
GFRP Reinforced Concrete slabs exposed to heavy traffic:

- will have fewer cracks
- will last 20 times longer

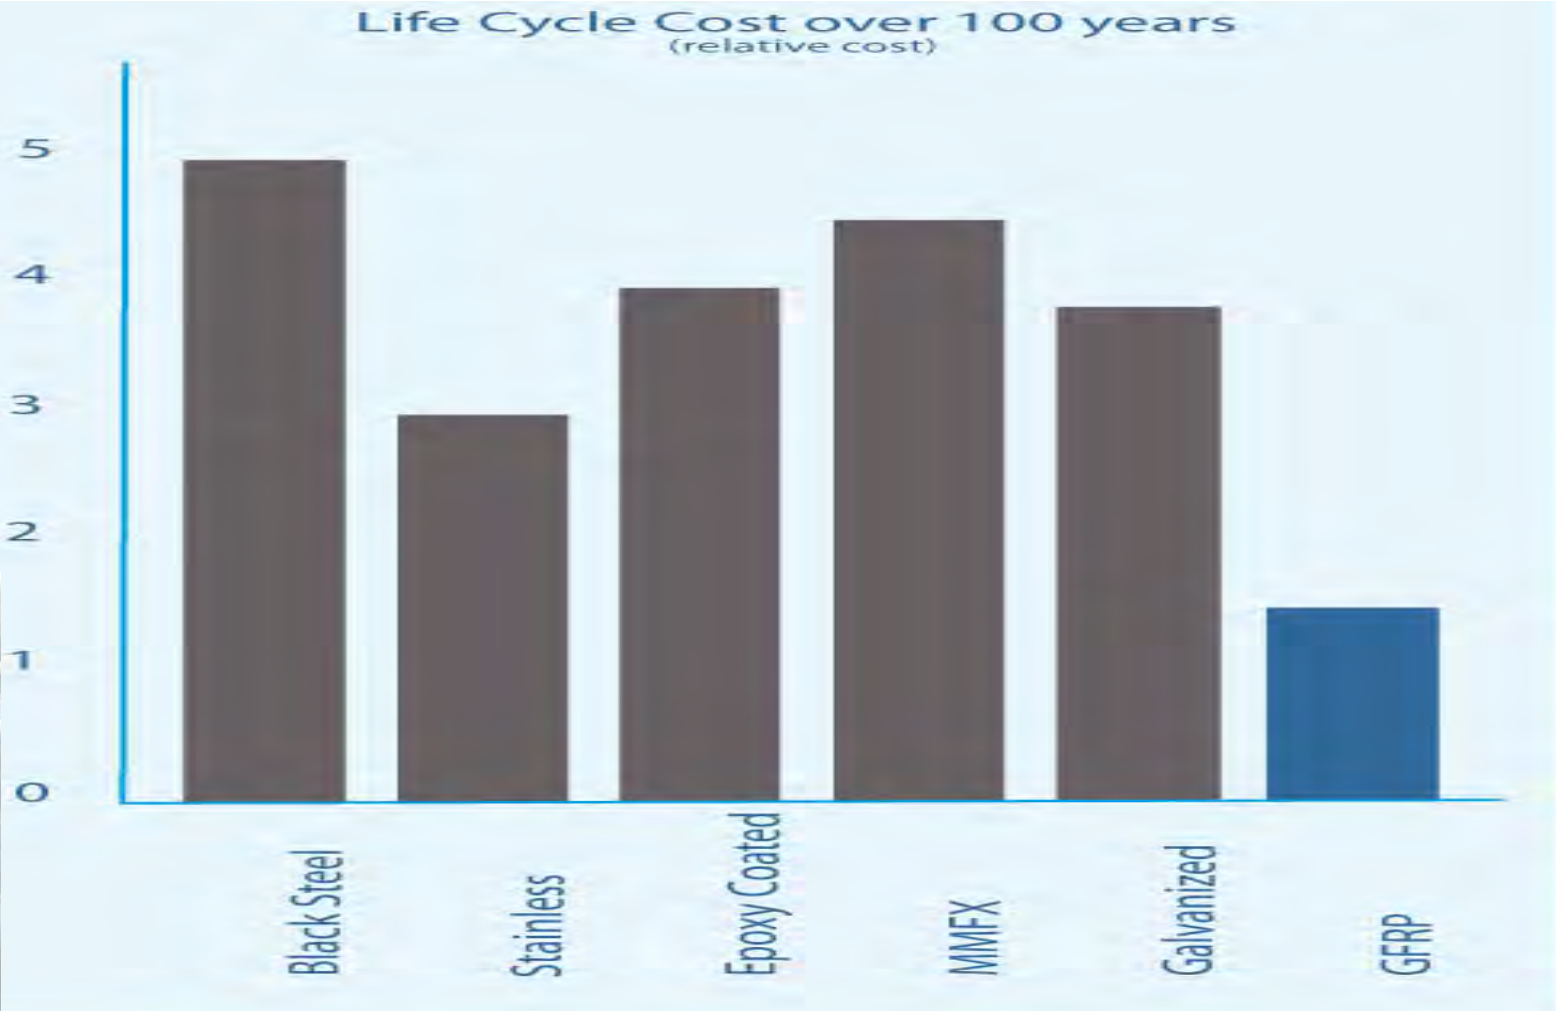
- 40-60% reduction in repair and demolition costs
