# Wheel Track Rutting Under Center Pivot Irrigation Systems

Research conducted by Warren Helgason  
Alberta Agriculture, Food and Rural Development (AAFRD)

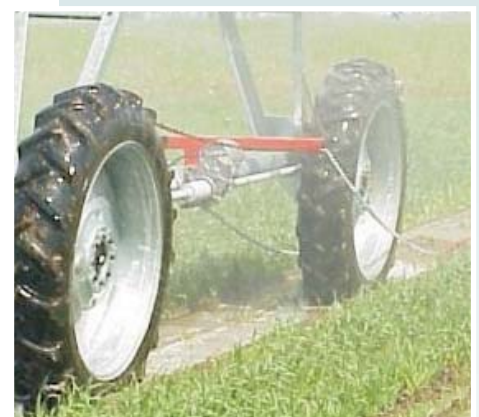
IMP(st) treatment

**IMPst:** The sled-type track closer consists of two thin rails, joined by a shaped blade. The sled is fastened onto the pivot tower with two chains. These attach to a bracket bolted to the tower. As the pivot rotates, the sled is pulled behind it. The rails of the sled straddle the rut and the blade relocates soil back into the wheel track. The pivot direction can be reversed by backing over the sled.

**IMPst** - The rut profile produced by the IMPst treatment was very variable, as the sled occasionally went off-track. Generally, this treatment resulted in the widest track of all those demonstrated, with a disturbed area measuring over 100 cm.

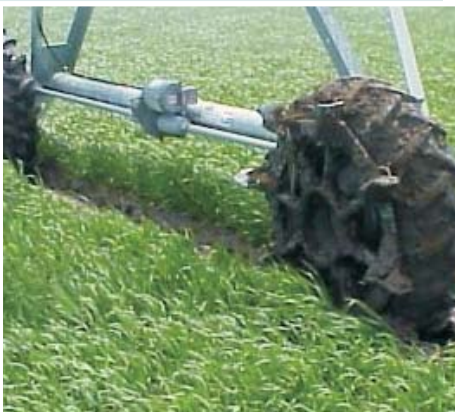
**TR/OET:** Traction rims, manufactured by Valmont Industries (Nebraska), were also evaluated. These rims bolt to the tire and provide extra traction in sticky soils. As the traction rim is only available for standard size tires, one pivot was re-equipped for this evaluation.

*TR treatment*

**TR/OET** - The profiles of this treatment were very similar in both years, despite different watering regimes and sampling locations. Visual observations confirmed this, as the track shape was relatively consistent around the entire track circumference. The resulting track was generally less than 10 cm wide, but measured wider than most other treatments. Overall, the traction cleats left a very rough rut profile, as the cleat lugs tended to churn the soil.

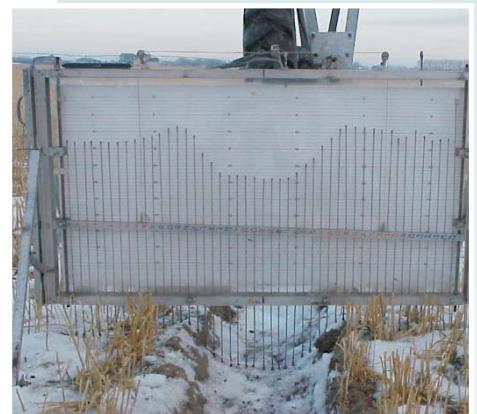
Continuous measurements of rut dimensions were taken using a rillmeter. The apparatus was placed across a rut and a number of steel pins were lowered into the track. The depth of travel was then recorded for each pin.

*Rillmeter being used to measure the dimensions of a center pivot wheel track*

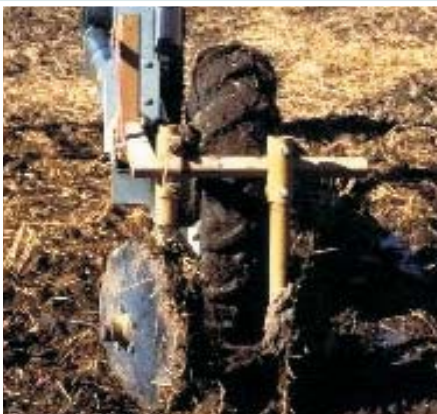
**IMPdt:** The disk-type track closer, with two disks mounted on a frame, is fastened directly onto the tower of the center pivot. As the pivot rotates, the disks move soil into the wheel rut. The depth of cut and the disk spacing (to accommodate the width of the wheel) can both be adjusted. The disks are designed to work in one direction of pivot rotation only.

*IMP(dt) treatment*

**IMPdt** - The IMPdt treatment produced a rut with a characteristic hump, representing the material that passes between the disks. In 2001, this treatment produced the deepest rut of all, measuring approximately 25 cm. In 2002, the rut was considerably shallower. Most significantly, there was no material displaced above the natural ground surface, as seen in most other treatments. The disks were not adjusted throughout either season.
