the WATER HAULER'S BULLETIN

VOLUME 28
SUMMER/87
ISSN 0827-2212

IN THIS ISSUE:

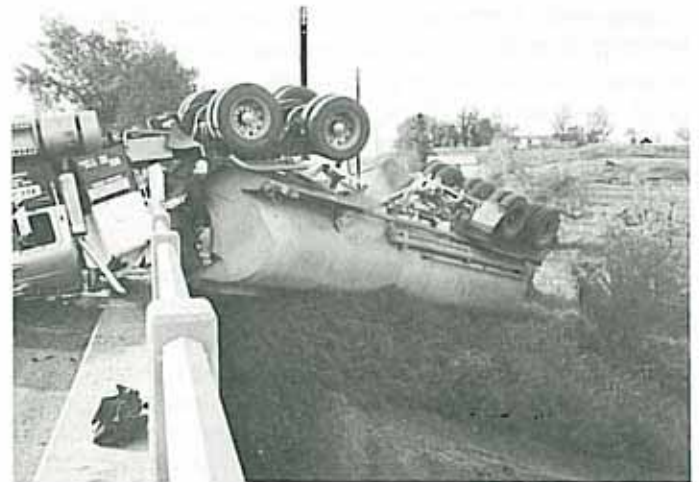
Photo Courtesy of: Trimac Transportation Services Ltd.

This accident occurred near Magrath, Alberta. Tanker spilled 20,000 l of diesel fuel into Pothole Creek.

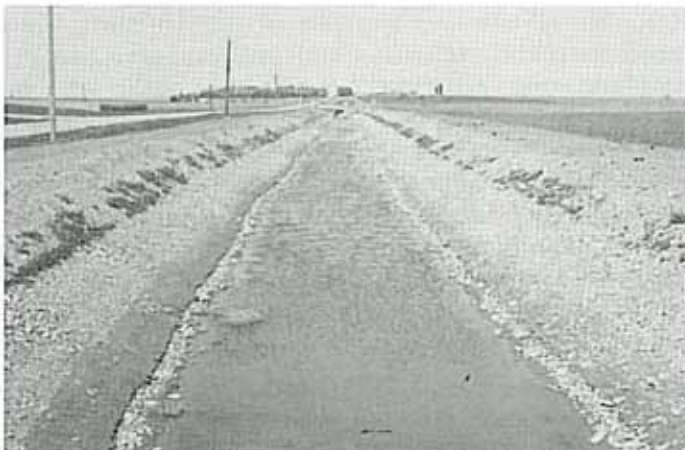
No sloughing present on this lateral after two years of service.

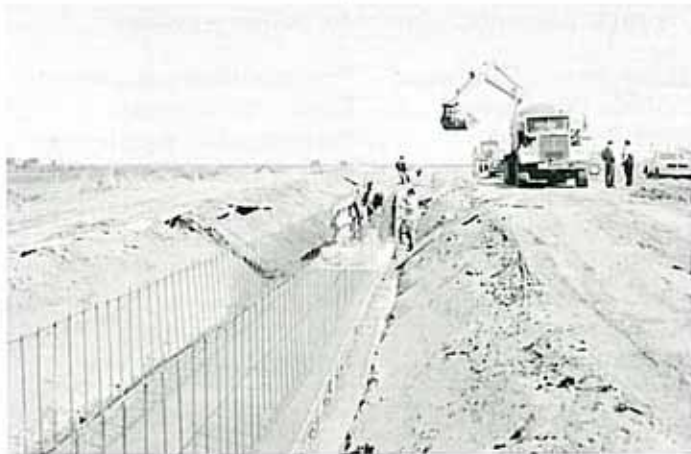
Using the leap-frog method, the floor forms are removed and placed ahead for the next pour. This same procedure is used for the wall forms. In this way, the District is able to complete approximately 60 m of channel per day.

Construction starts with stripping of topsoil and excavating a trench with 1:1 side slopes to 300 mm below design bed grade of the finished concrete channel. Forms are placed 1.5 m apart at floor elevation and bed grade on 150 mm of crushed pit-run bedding. Steel rebar (10 M) used for the floor and walls is welded together on site and placed at 300 mm oc spacings both horizontally and vertically. The 150 mm floor is then poured and trowelled. A 40 mm square waterstop groove is made in the floor where the walls join. After the floor has set, forms are set up for the walls.

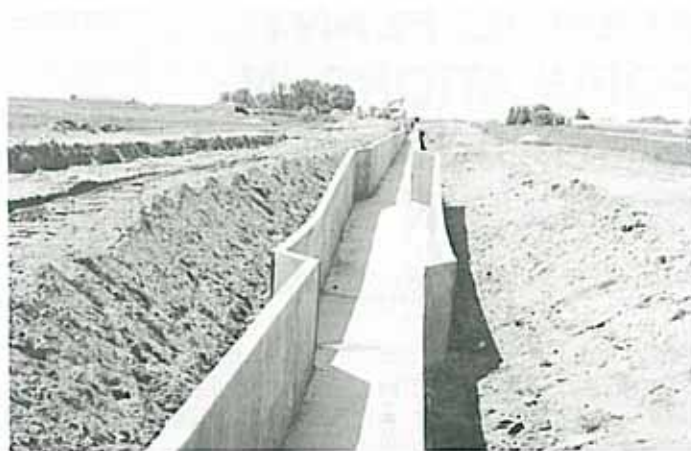
The canal section is widened for the chute drop and the resulting hydraulic jump.

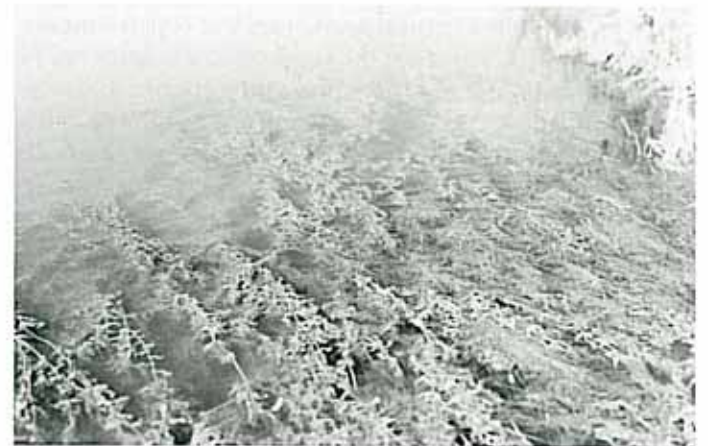
Richardson's Pondweed has reduced the cross-sectional area of this canal to where it has become a Ditchrider's nightmare.

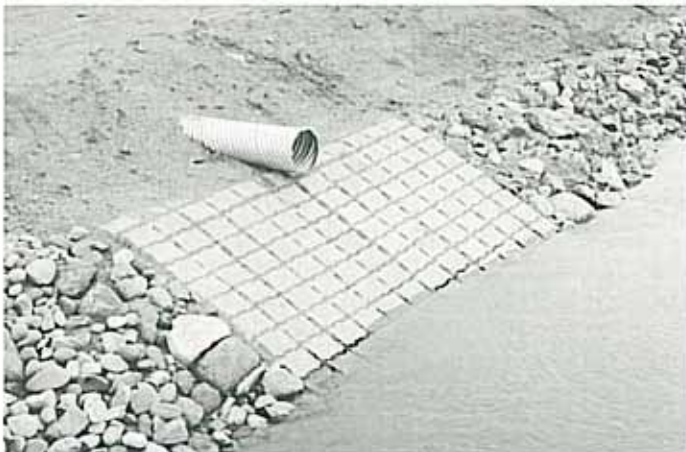
Concrete revetments can be installed in the off-season without conventional heating and hoarding costs.

The flexible concrete revetment consists of precast concrete blocks, laced together with structural cables and pre-assembled into flexible mats. On site, the mats are installed on a geotextile and connected together. Where required, the mats can be anchored into the sub-base soil by industrial soil anchors.

The St. Mary River Irrigation District has installed one of GST's new flexible concrete revetments on a drain inlet into their Main Canal just east of Lethbridge. According to Jim Brown, District Manager, an alternative to rock riprap and the old standard cast-in-place concrete slab was needed as neither of them worked very well. The riprap always ended up slipping off the side slope and into the bottom of the canal. While the cast-in-place concrete slab is susceptible to frost heaving and the resulting damage. The Project Planning Branch will be monitoring this new installation and will keep readers posted in a future "Update" article.
