WATER HAULER'S BULLETIN

IN THIS ISSUE:

CANAL ROTOVATION	1
FLAX-STRAW & ROCK DROPS	2
KARMEX UPDATE	3
CAP IT - BURY IT - FORGET IT	4
AGRICULTURAL LAND INFORMATION SYSTEM	5
MOISTURE RETENTION TESTS IN SANDY SOILS	6
SALINITY MAPS OF IRRIGATION DISTRICTS UNDERWAY	7
UPDATE: AQUA LINER	8
INSERT - CONFERENCE

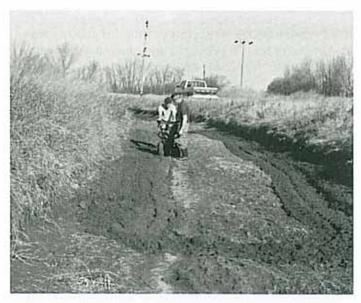
Although it doesn't look it now, this reach of canal is badly infested with aquatic weeds.

The rotovation experiment was designed to study the effect of exposing this rich organic mud layer to desiccation and/or freezing. By tilling the canal bed, the organic insulating mat was disrupted and the canal bed hydrosoil stirred up to allow for fall drying and subsequent freezing during the winter months. The overwintering tubers and crowns should be disrupted and moved to the surface for exposure to the sun and freezing air. And lastly, the anaerobic conditions in the hydrosoil to the depth of 20-30 cm will be disrupted and oxygen introduced to the exposed tubers and crowns.

A total of five test sections were tilled. The tillage was done by using garden tillers with both spike and flat blade attachments. Tillage depths varied between 150 mm and 300 mm and each plot averaged approximately 20 m in length. Frost tubes were also installed with one installed in the tilled area and one in the control section.

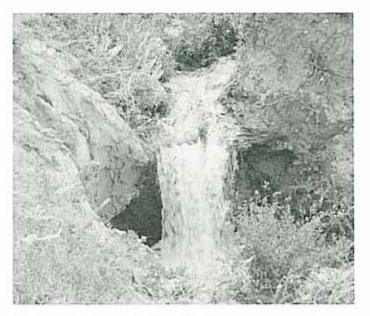
Erosion occurring prior to installation of the rock drops.

Originally five rock drops were installed in 1982 in Drain 64 Hays. Of these, two were vertical drops, made by containing rocks in a vertical shape by use of steel posts and welded wire mesh. These two vertical drops kept on washing out the earth at the abutments until

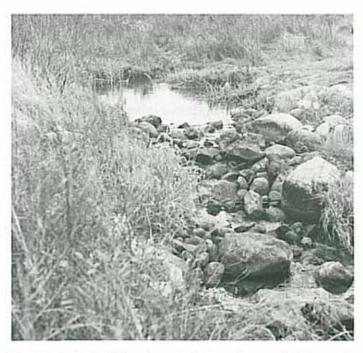
Rock drop in Drain 64 Hays has stopped erosion – excellent regrowth of vegetation occurring.

Our 1987 inspection revealed that all nine structures are functioning well and that a considerable buildup of silt has occurred. Vegetation is starting to grow back. This is a complete reversal of the process that was occurring in the coulee prior to the installation of the rock drops."

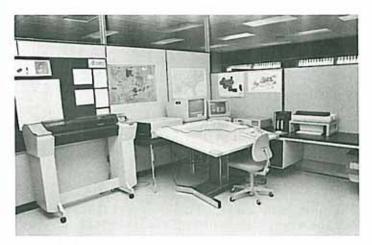
AgLIS Computer System in Lethbridge.

Each primary system consists of an IBM PC/AT with one 1.2Mb floppy disk drive, one 30Mb hard disk drive, and one 70Mb hard disk drive. Peripherals include a Calcomp 1043 GT 8 pen drum D/E size plotter, a Calcomp 9100 digitizing table (with 36" x 48" active area), and a CIPHER Series 9000 Magnetic Tape Subsystem. Software includes the GeoBased Systems STRINGS(TM) Geographic Decision Support System (for planimetric and thematic mapping) and AutoCAD (for engineering design and drafting) from AutoDesk Inc.

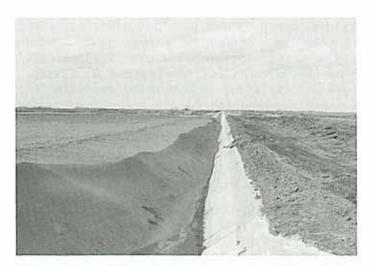
Taber's Northeast Fincastle Lateral – sandy soil blown in from southern Alberta's strong westerly winds.
