the WATER HAULER'S BULLETIN

VOLUME 47
SPRING 1992
ISSN 0827-2212

THE GOOD, BAD AND UGLY	1
CONDITION EVALUATION OF REHABILITATED PROJECTS	3
THERMALLY ACTIVATED VALVE FOR FROST PROTECTION	4
SEEPAGE PROBLEM ALONG THE CHIN 1 PIPELINE	5
FROM THE FARM PERSPECTIVE	6
A PROJECT OF COOPERATION	8

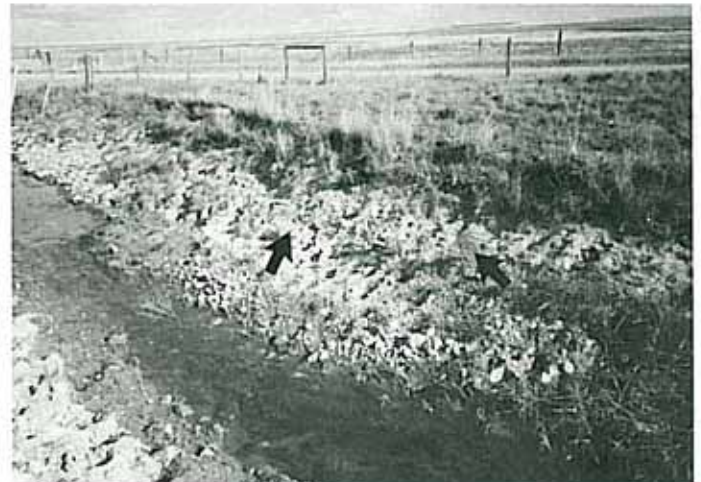
Arrows point to buried polyethylene lining that has been exposed due to cattle trampling earth bank when coming to drink.

The present condition of the rehabilitated projects within the above mentioned districts is rated as "fair" to "very good" with a few isolated problems. Some of the problems typical to each district are firstly, a never-ending problem of erosion, siltation and vegetative growth in canals and around irrigation structures; secondly, poor or no vehicle access. Better access along canals in some districts would alert district personnel to potential problems developing within their systems and thirdly, the trampling of canal systems by livestock.

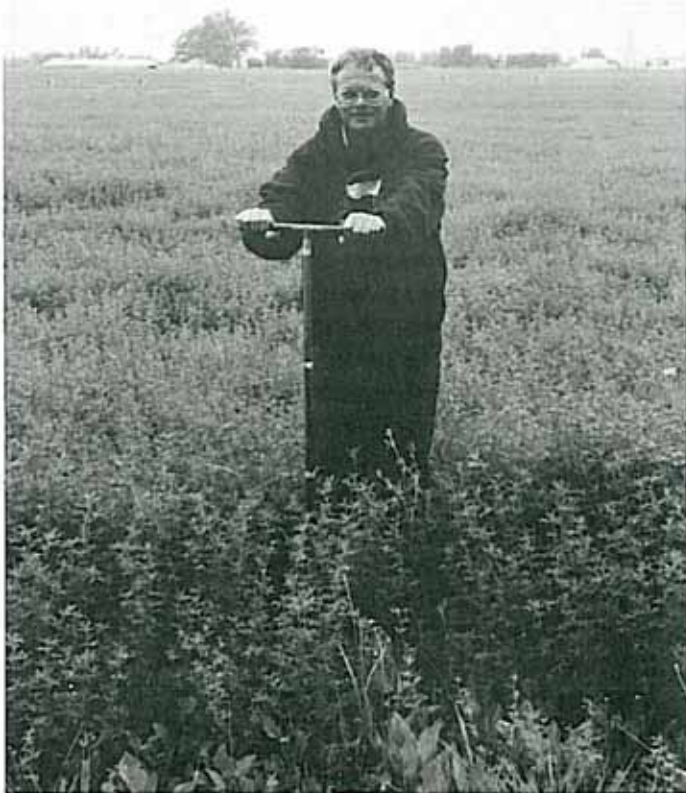
Senior Technologist Wayne Ulmer checks elevation of water table.
