St. Mary River Irrigation District

Gabion Wall Infiltration Systems

Aquatic Weed & Algae Control Structures (2010): IRP #2192

Performance Update

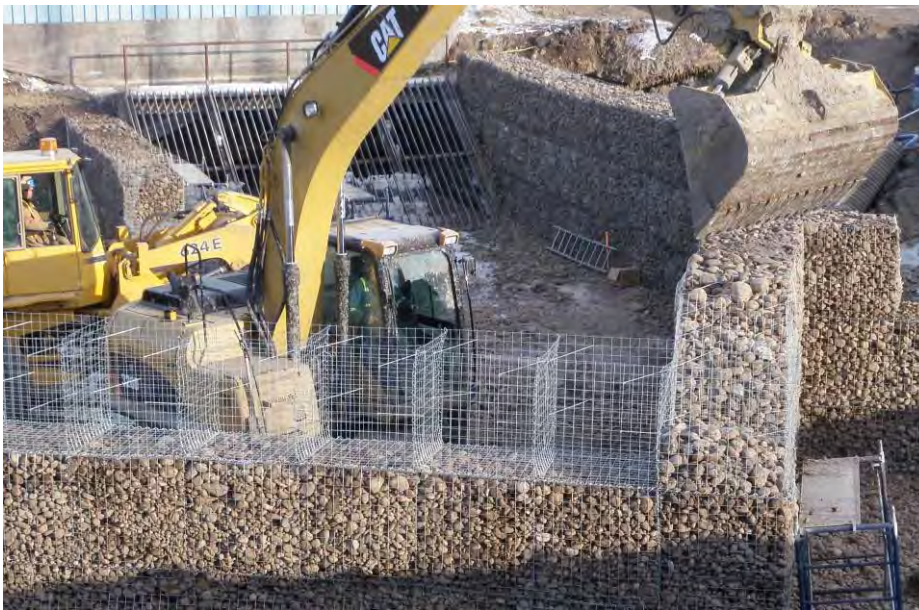
All systems were constructed from Atlantic Industries Limited welded wire gabions assembled and installed by SMRID forces from 11 gauge galvanized roll stock, 12 gauge galvanized spirals and 9 gauge galvanized corner stiffeners. Baskets were custom cut and pre-assembled in the shop and transported to site for placement, joining, filling and in some cases topping. Pre-assembly included lifting, joining and stabilizing (with corner stiffeners) of the side panels as well as the intermediate panels that form the 1 m long cells.

This system was preferred over the conventional double twisted mesh (typical of chain-

link fence) for the ability to lay flat, hold their shape and be easily joined by twisting a spiral wire instead of hand lacing. This system was easy for the crews to learn, minimized outdoor exposure and allowed most of the joining
