# Travers Reservoir Rehabilitation Project

2010 Irrigation Technical Conference  
Lethbridge, AB  
June 2, 2010

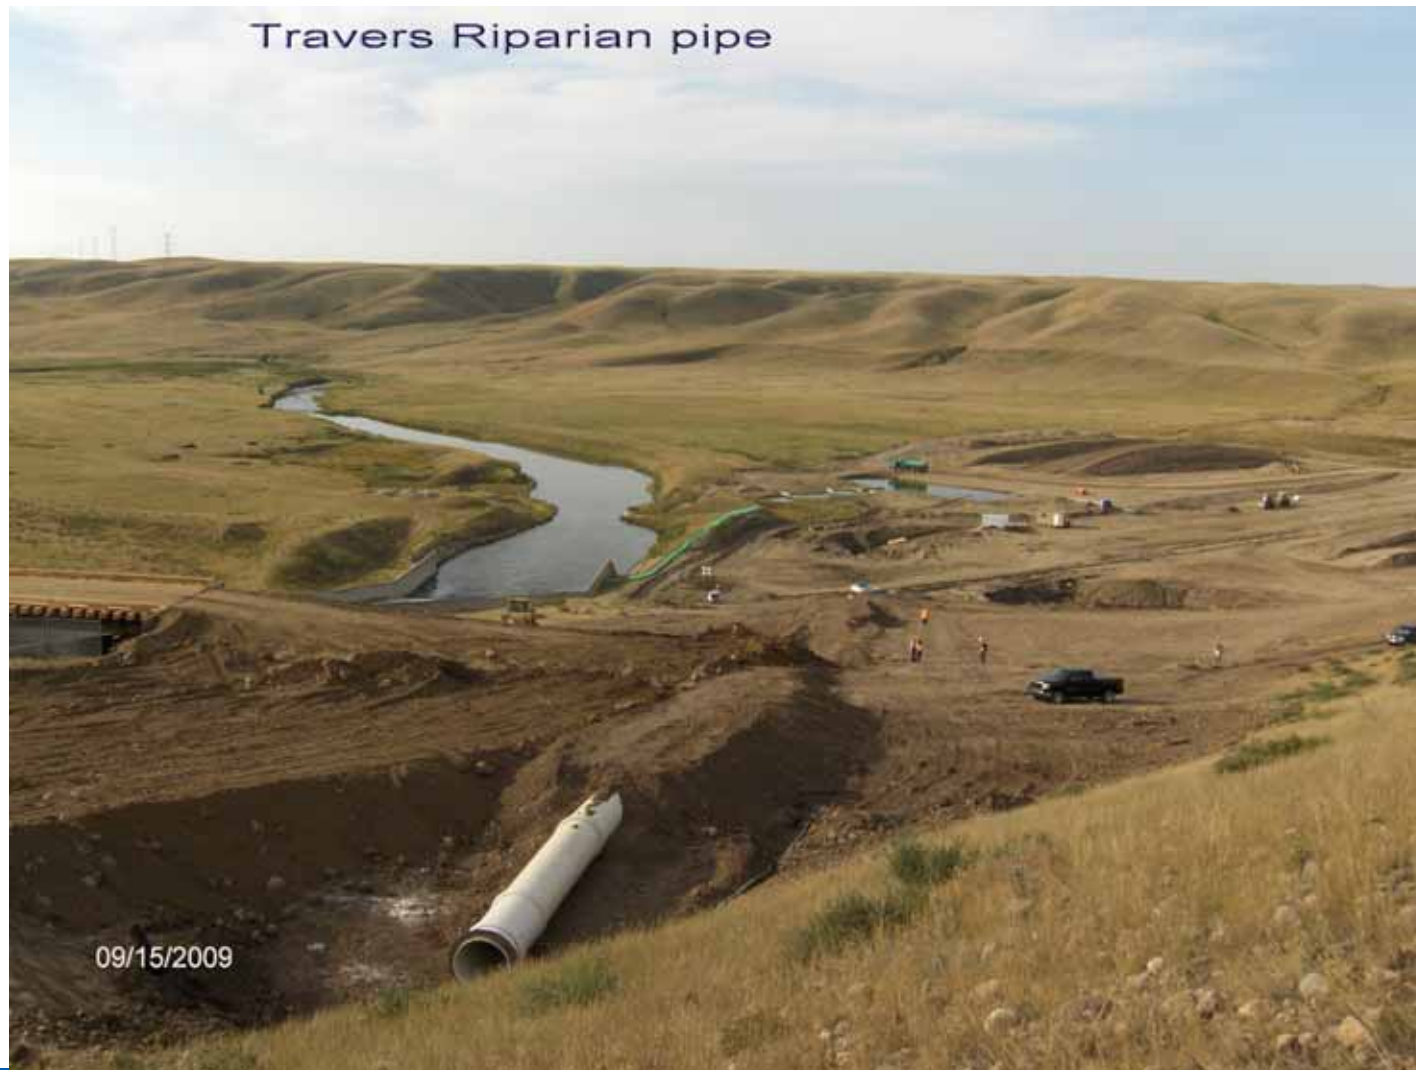
# Stage 1 Work

- Main Embankment Stage 1 key work:
  - Construct lower earthfill berm (to Elev. 850.0 m) on Travers Dam to flatten slope
  - Borrow material from irrigation outlet canal enlargement
  - Relocate riparian outlet to Little Bow River
  - Construct toe drains and main embankment seepage collection and monitoring system
