## Travelling Water Screens to be Installed in BRID

## Aquatic Weed and Algae Filtration Systems

## Combination Air Valves Testing Preliminary Results

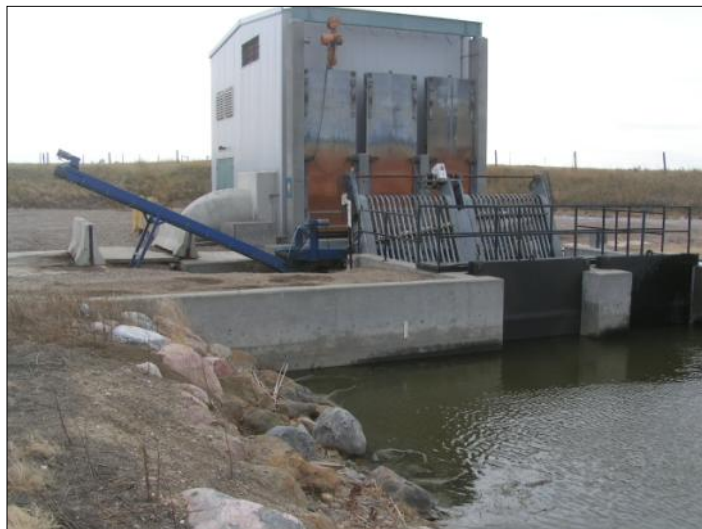
Pump house screens to be replaced

Deteriorated automated trash screens on the BRID's Lost Lake pump house intake are being replaced with large travelling water screens manufactured by Hydrolox Engineered Polymer Screens of the USA.

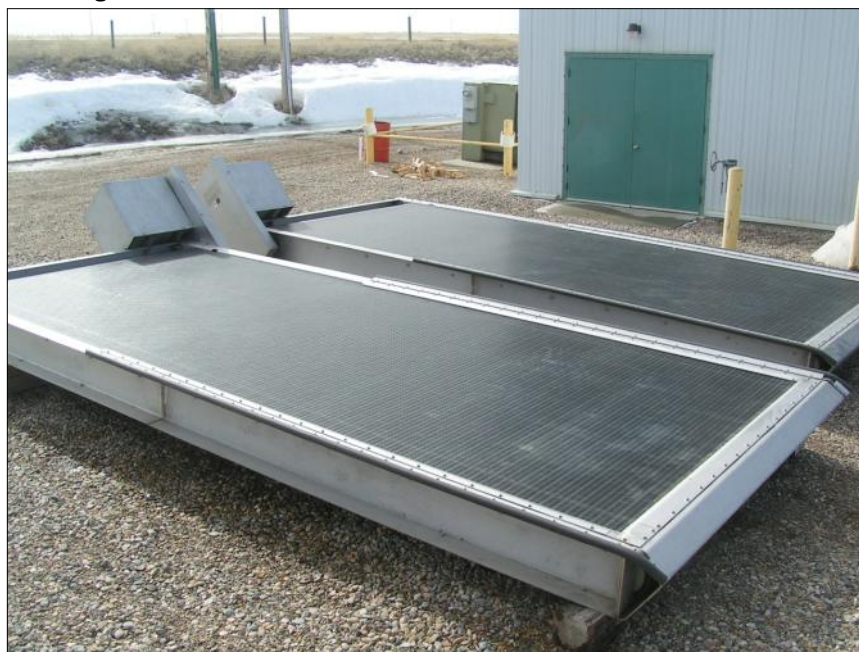
Travelling water screens to be installed

These screens are made from corrosion resistant polymer modules assembled in an interlocked, bricklaid pattern with full length hinge rods in virtually any width and length. Screens are light weight with built in strength and durability.

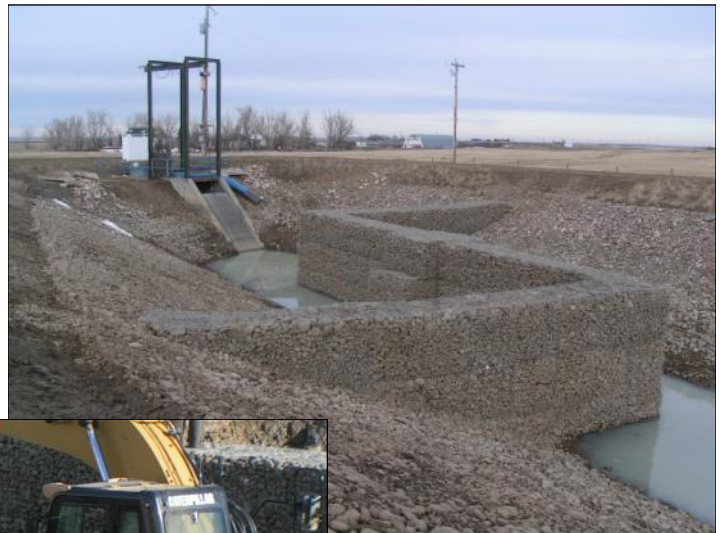
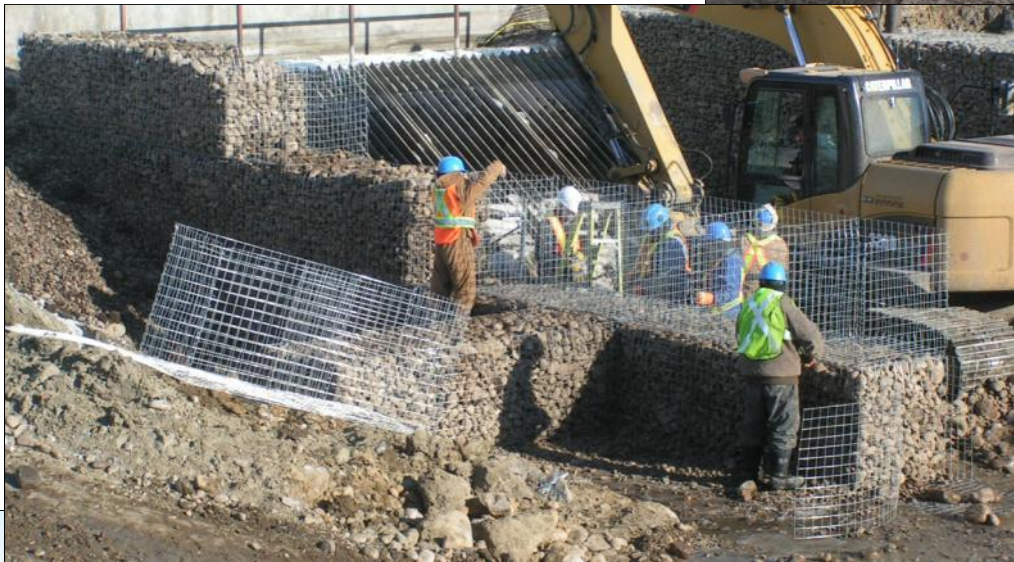
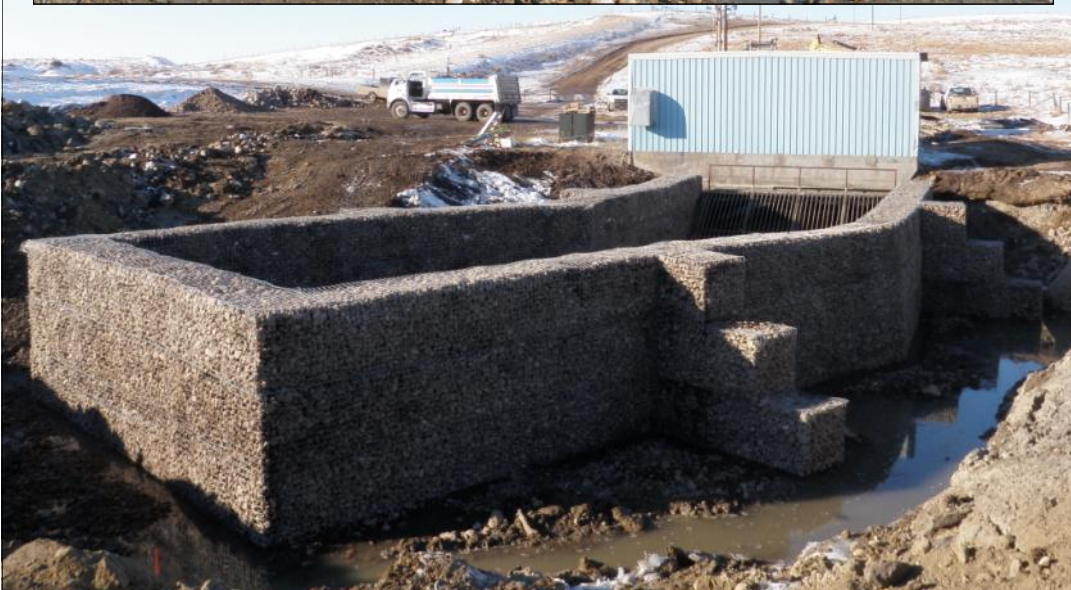
In view of this, the SMRID has developed some long term strategies for controlling aquatic weed and algae problems to ensure clean and adequate water delivery to their users. Three technologies are being implemented for testing at several locations throughout the district: (1) the gabion wall infiltration system – designed to exclude weeds from the canal turnout or pipeline inlet; (2) the infiltration gallery is permeable pipe within a gravel envelope connected perpendicularly to the inlet structure; (3) a floating net boom for pipeline settling ponds designed to intercept weeds and algae entering the pond.

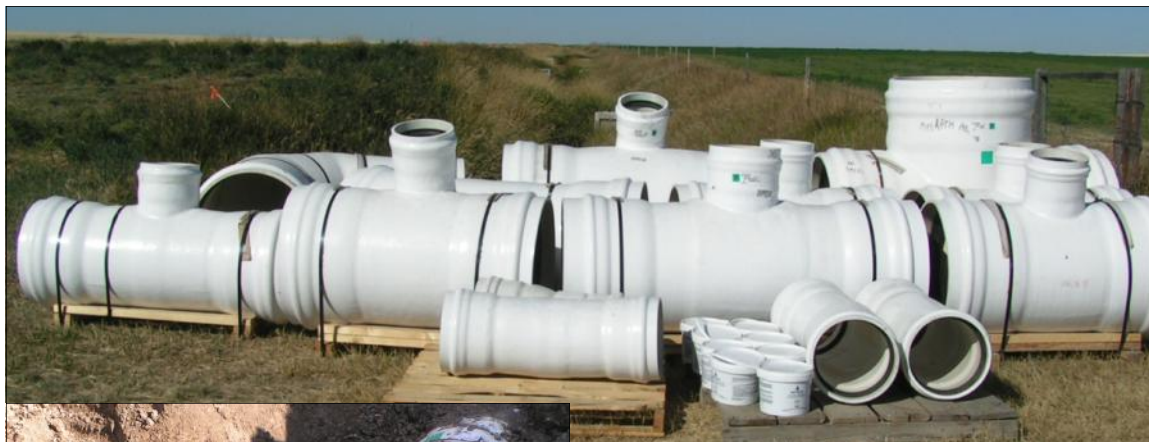
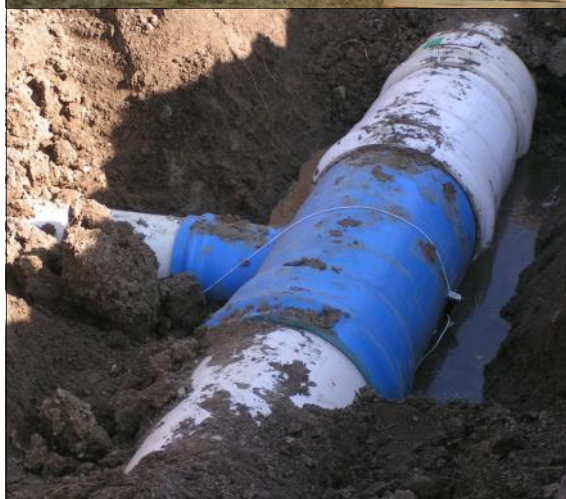
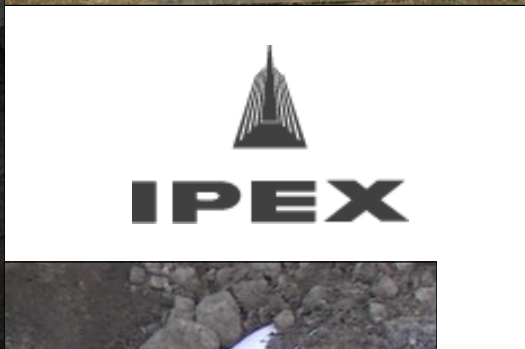
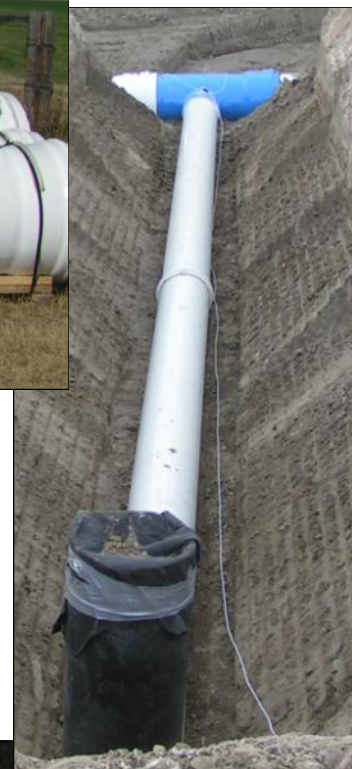
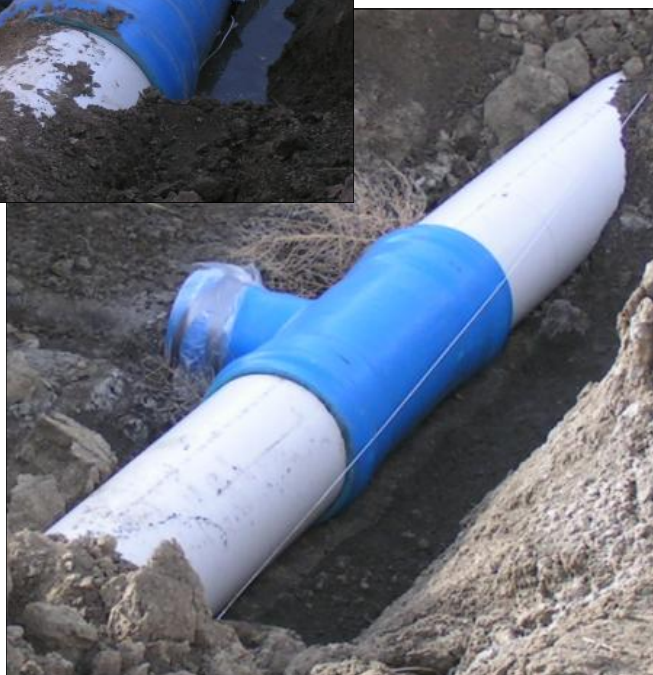
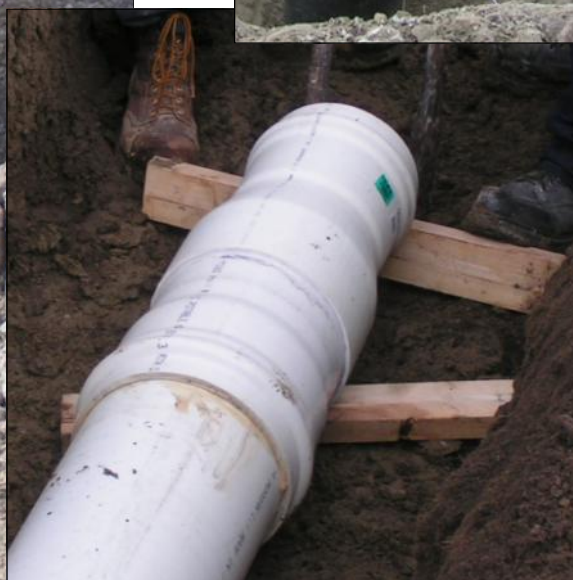
Most of the time, a bell has to be cut off the next length of pipe to join it to a reducer or tee fitting.

Using a bell by spigot fitting in

such cases would save time and money and reduce wasted pipe.

Bell by bell of course is still necessary, on some fittings, especially when needed to re-

verse the bell at the end of a pipe to insert a steel riser.

Bell by spigot fittings are easier to manufacture and thus, slightly cheaper than bell by bell.

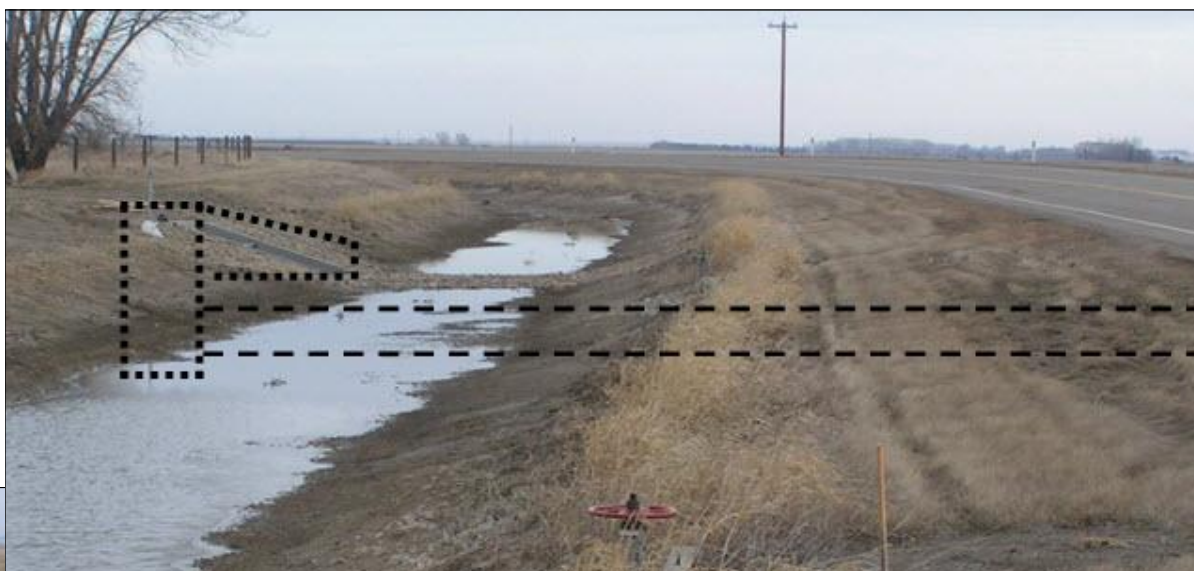
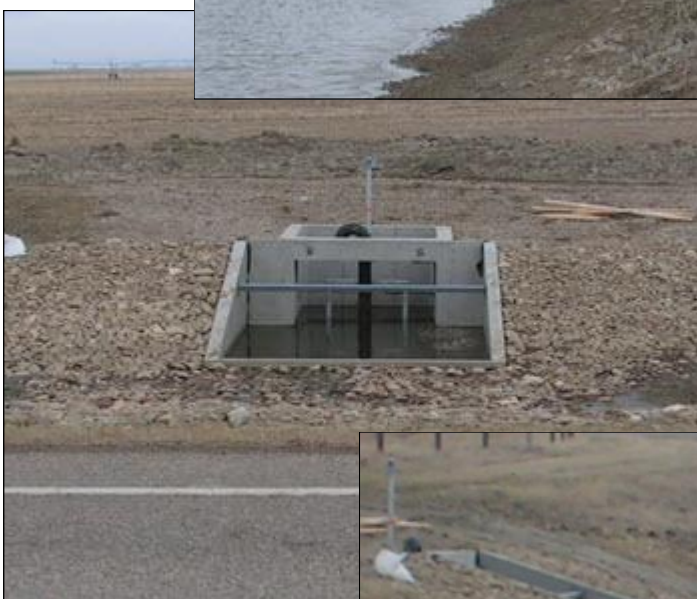
Instead of a drop inlet with gate and pipe directing flow through the embankment on the same side, the gate and pipe direct flow back under the bed of the channel through the opposite embankment and through the highway casing pipe.

Inlet precast panels are made by Precon Manufacturing Ltd.

pipelines must cross through the highway to serve irrigators. But, in areas where there is a lack of right-of-way between the lateral and pavement to install inlet structures, the district engineering staff designed a "backward" inlet structure coming off the opposite side of the lateral.

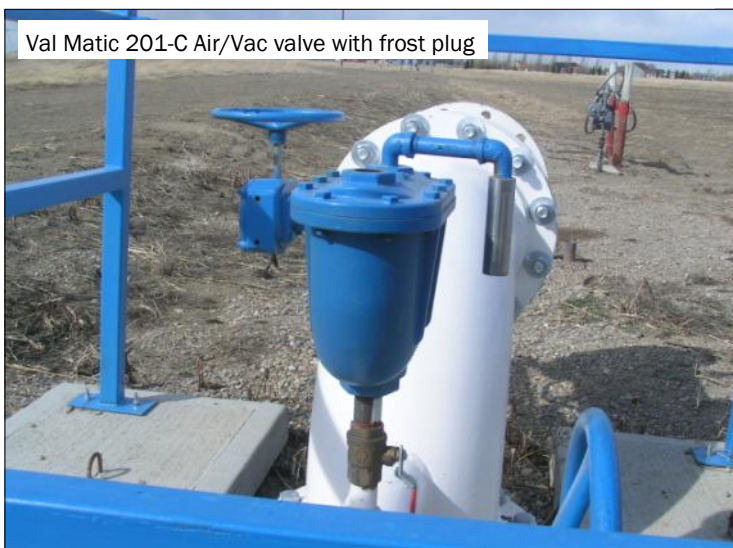
Val Matic 201-C Air/Vac valve with frost plug

As the Val-Matic 201-C has a history of failure due to seizing of parts and leaking of seats and was observed with these problems during the test, this valve receives the lowest performance rating.

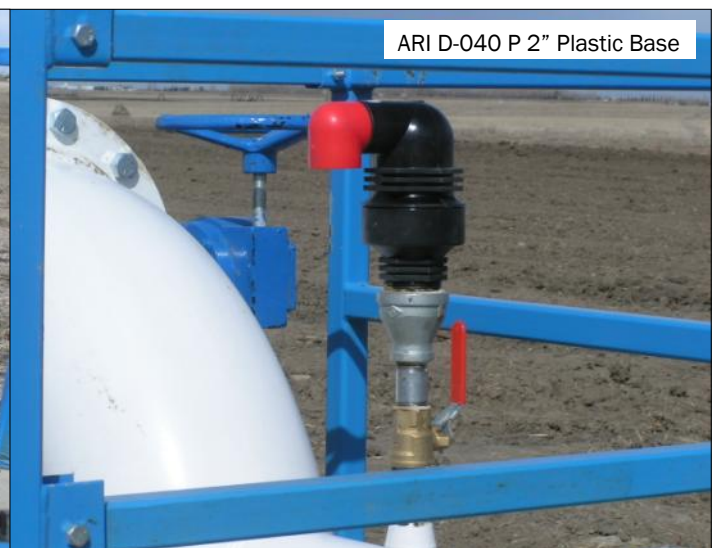
ARI D-040 P 2" Plastic Base

There were no seating, performance or frost resistance issues identified for either the ARI D-040 P (plastic base) or D-040 B (brass base). The only disadvantage of the ARI valves (and Nelson ACV200P) would be the loss of operation compared to the Val-Matic 201-C during sustained freezing temperatures. As this situation would be quite rare and that it would be very unlikely that irrigation would be happening at this time minimize this downside. The other problems noted with the Val-Matic 201-C, including farmer override on leaking valves, seizing, etc. are more of a concern than this temporary loss of function. Based on the current testing there is no apparent advantage to using the brass base so long as a reasonable level of care is taken in handling, threading and tightening the valve. At this time the anticipated potential difference in long-term failure rate due to the selection of base materials (say 1%-5%) does not justify the increased cost (67% or approximately \$100/valve).

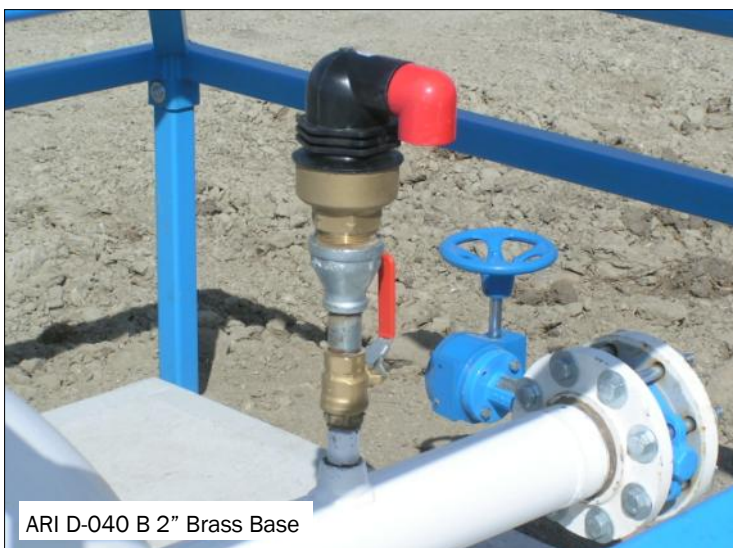
ARI D-040 B 2" Brass Base

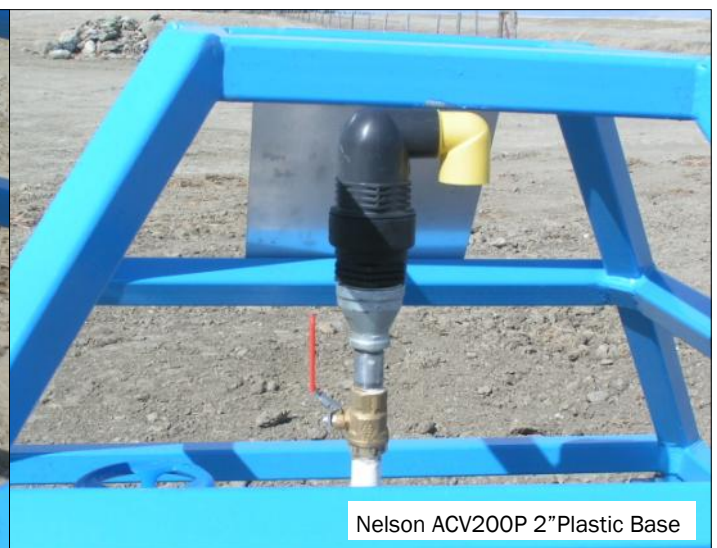
Nelson ACV200P 2" Plastic Base

The lone seating issue found with the plastic valves was a Nelson ACV200P on an unused domestic turnout that was found slowly dripping late in the season. Algae were found to be growing on the drainage elbow. After flushing the domestic turnout line and successive draining and refilling of the valve using the draining ball valve installed below, the valve stopped dripping.

The leaking of the Nelson ACV200P due to algae buildup may be an exception for the site, but does indicate a potential for future problems. The ability to quickly flush and reseal (where a draining ball valve is affixed) is an advantage over the Val-Matic 201-C. The cracking of the base during frost at the same location and with the same pattern on two occasions indicates a limited ability to handle freezing conditions. This vulnerability of the base may be due to the smaller volume of the body, the incompressible float (ARI's is foamed polypropylene) and/or the thin polypropylene base (ARI's is thicker and made of nylon). The failure rate of 2/9 or approximately 20% is high. The reduced operability during frost conditions compared to the ARI valves may be a characteristic of the size/shape of the valve (ARI is larger), the materials, the internal geometry and/or the seal characteristics. Regardless of the mechanism, this provides an indication of the ability to continue to operate during partial frozen conditions while the Nelson valves are already/still frozen.

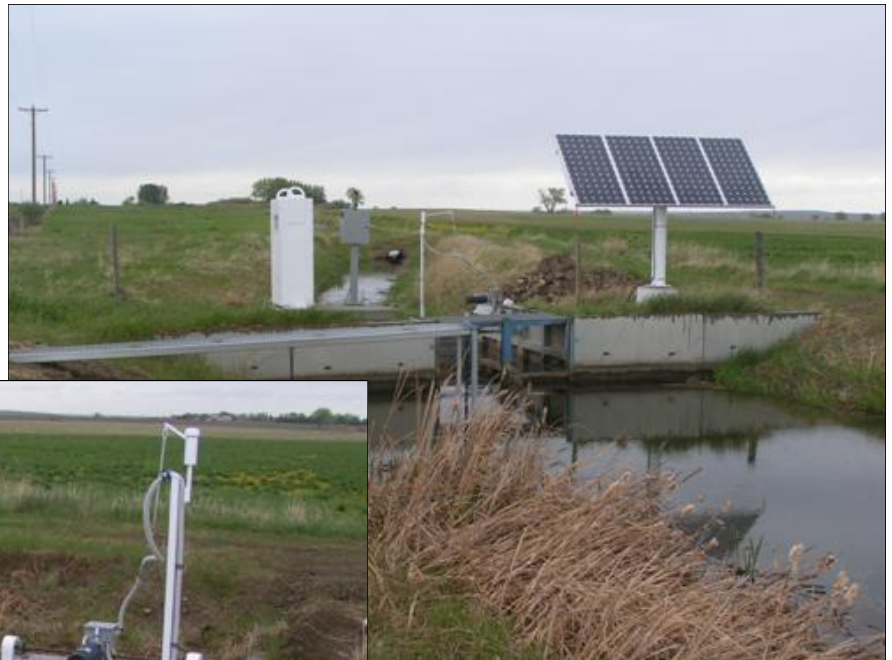
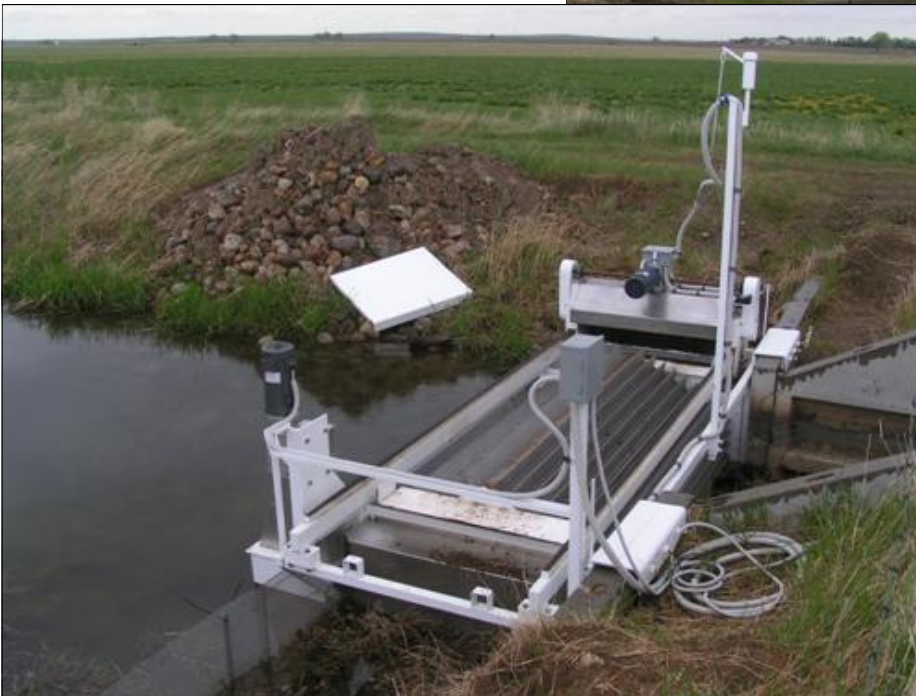
cleaner designed to screen the whole canal flow. The screen is a big hexagonal shaped drum made of perforated plate that is folded like an accordion to maximize the screen area. Attached to the downstream side of a structure, the drum rotates and picks up debris out of the water. A brush runs in both directions horizontally over the drum sweeping debris off both ends. The hope is that this screen will remove weeds/algae/debris from the canal and the water would be good

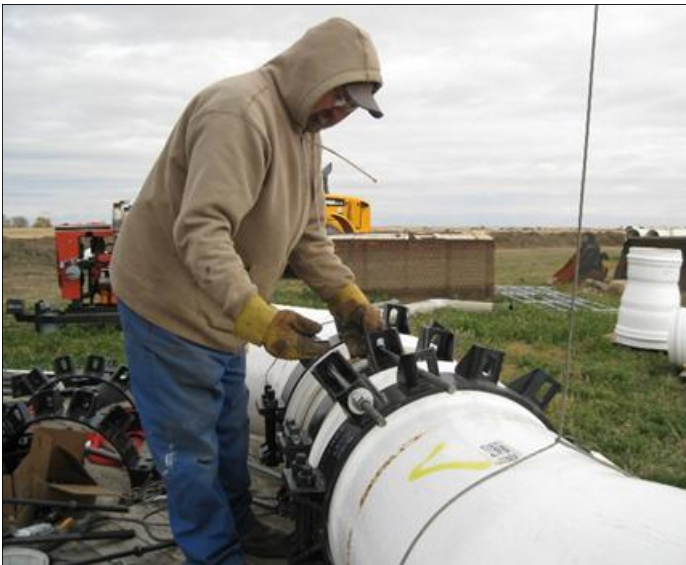
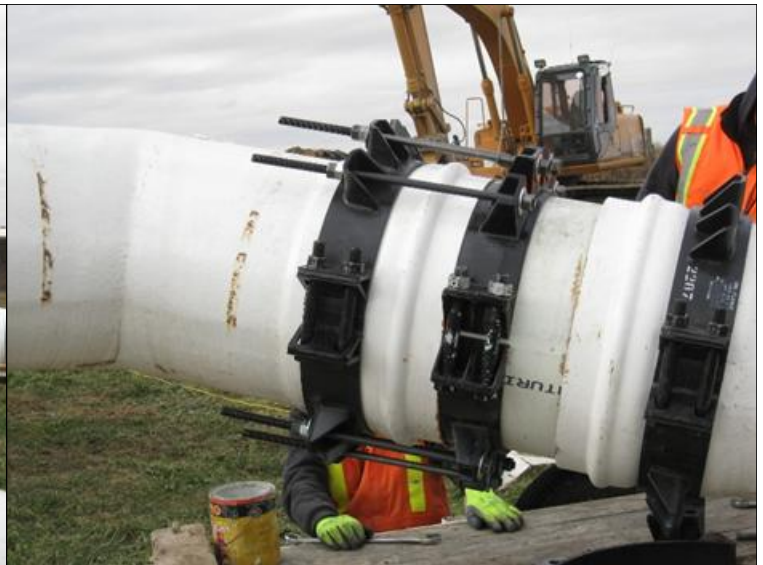
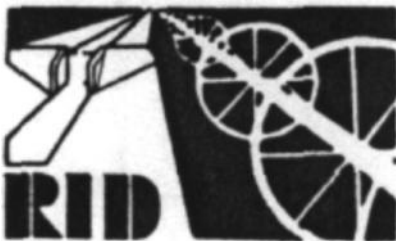
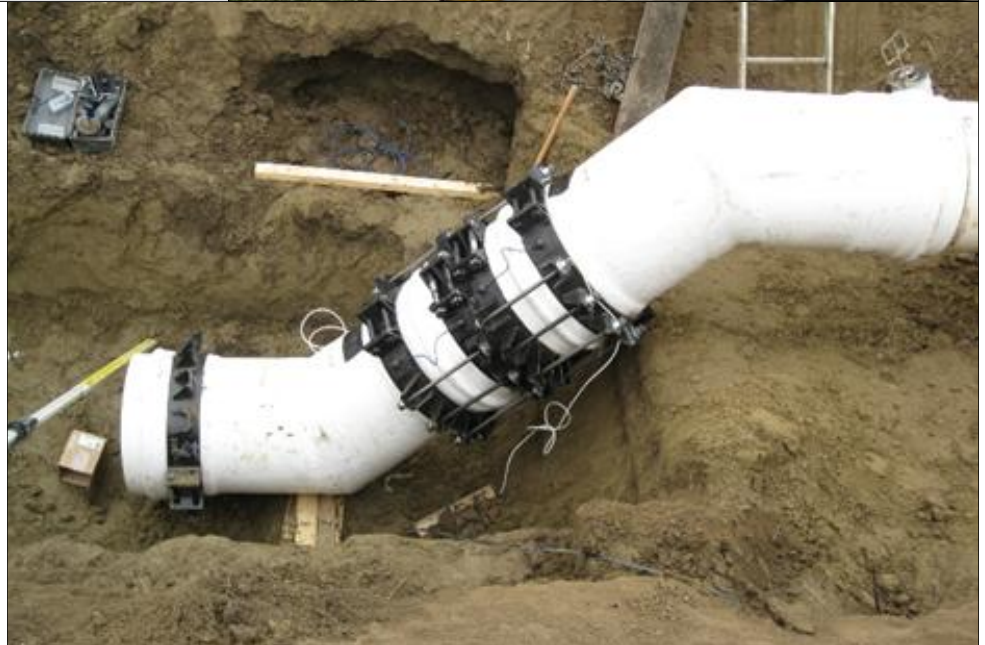
Joining a new pipeline to an existing pipeline required a 1.4 meter "Z" drop. Normally, a steel "Z" drop would be fabricated and installed requiring thrust blocks to prevent movement. This means leaving the trench open while waiting for the concrete truck to arrive, sometimes building forms, then leaving the trench open for the concrete to cure,

Joint restraints can be designed to fit all sizes of pvc pipe fittings and require only a wrench to assemble.

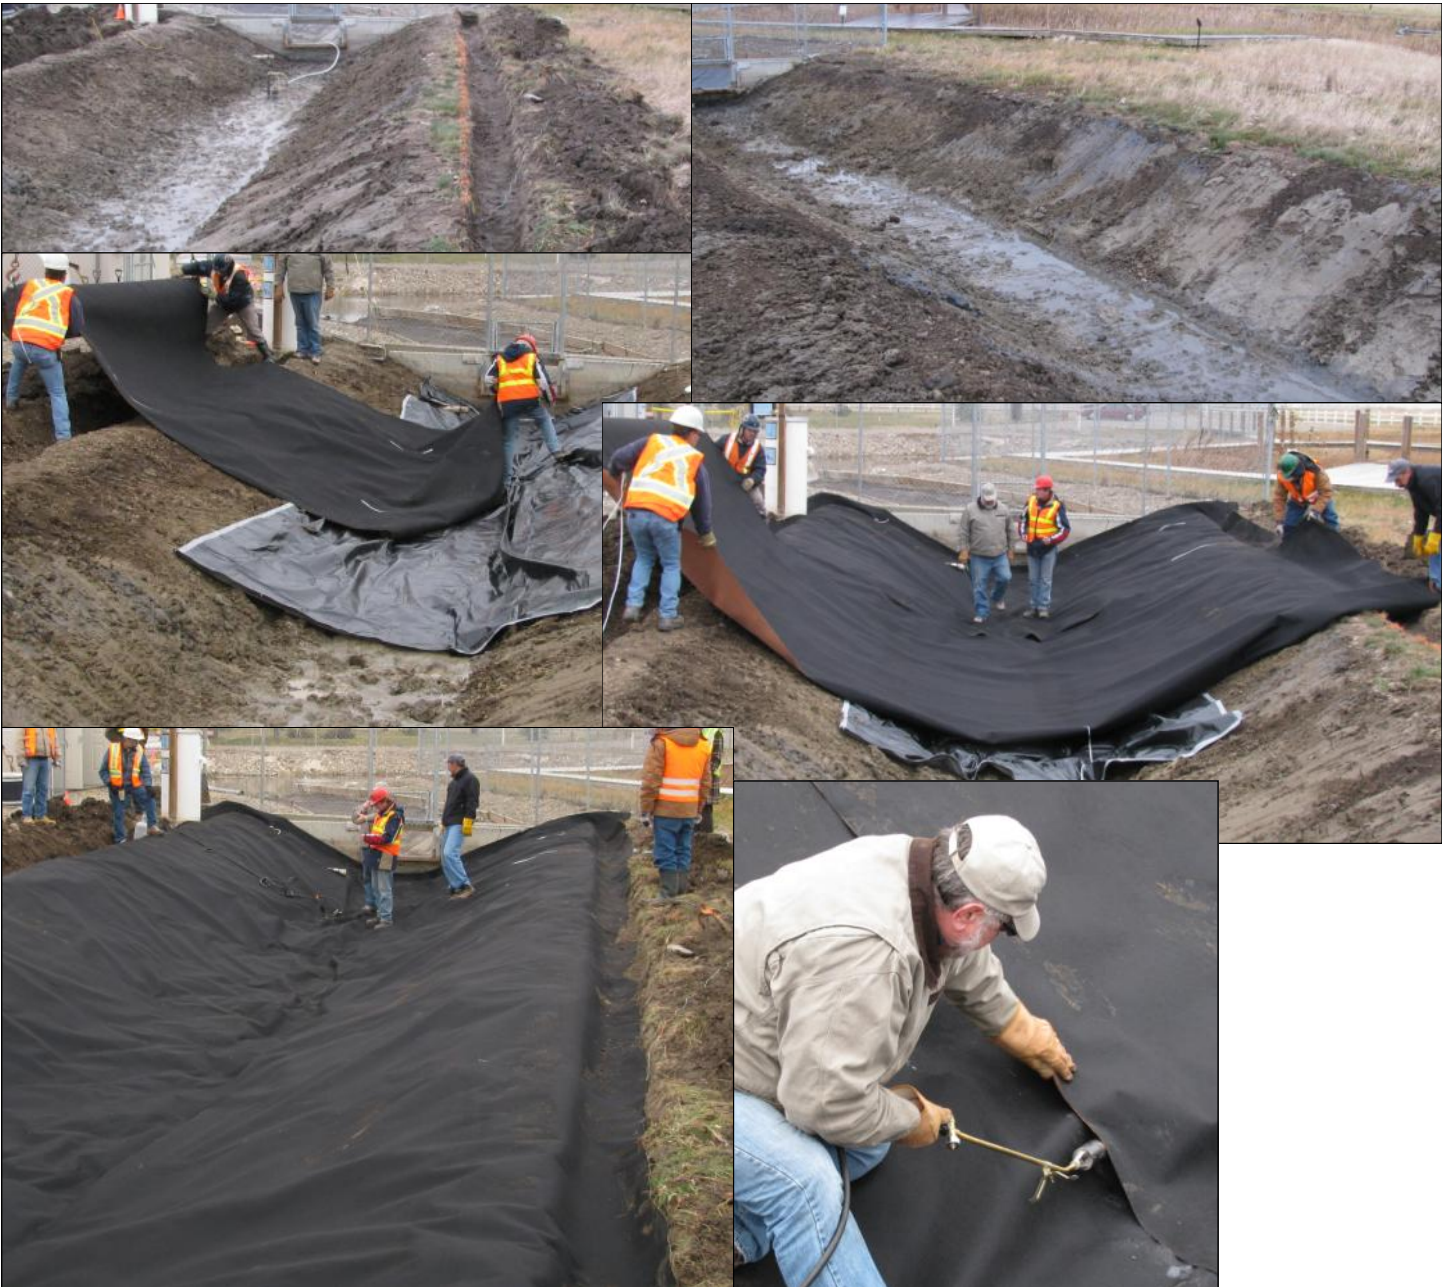
Recently, a short reach of the demo canal at the CACDI Irrigation Development Center in Lethbridge was lined with a geocomposite geotextile that consists of two polyester non-woven material bonded one on each side to 20 mils of an EVA geomembrane.

The liner, named Canal<sup>3</sup> 8208, made by Huesker Inc of North Carolina, is designed for use as an impervious barrier.

Site preparations and liner installation was provided by the St Mary River Irrigation District under the direction of the Huesker representative.
